ILLINOIS ENVIRONMENTAL PROTECTION AGENCY

1838130004—Vermilion County
 Oakwood Twp/Bunge Milling Inc
 FOS File
 Inspection Date: 10/15/2014
 Inspector: Jeff Turner

Coal Combustion Byproduct Fill Site Inspection Report

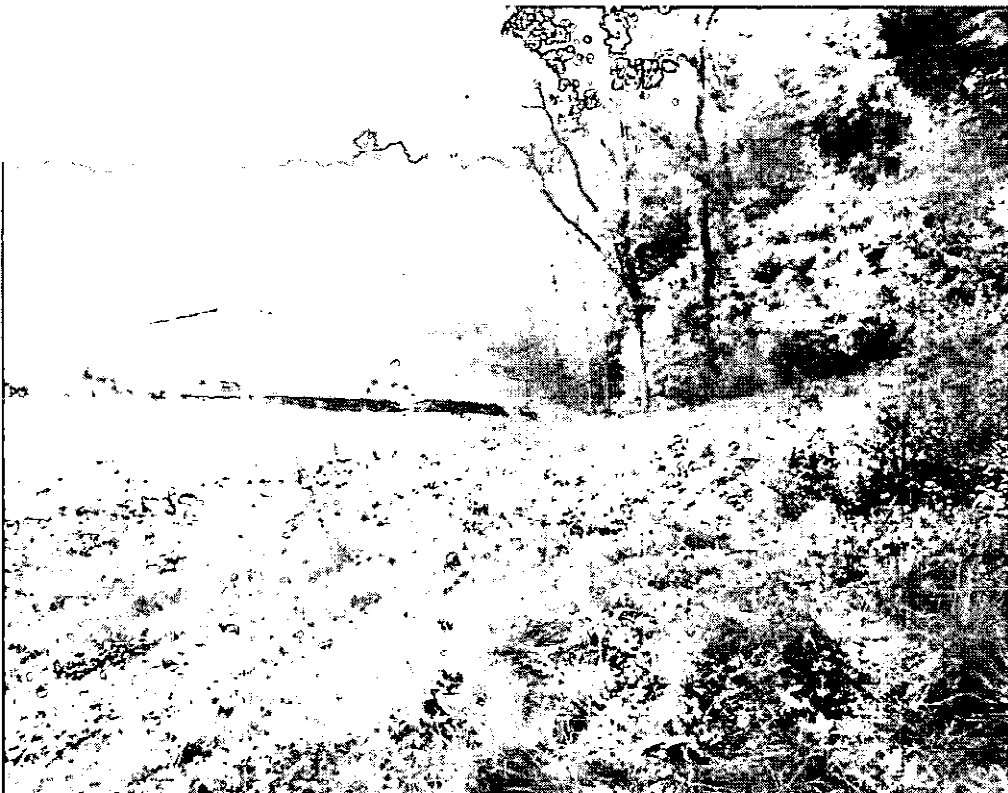
Date: 10/15/2014
Time: 10:40 A.M.
Direction: North
Photo by: Jeff Turner
Exposure #: 002
Comments: Main runoff collection area

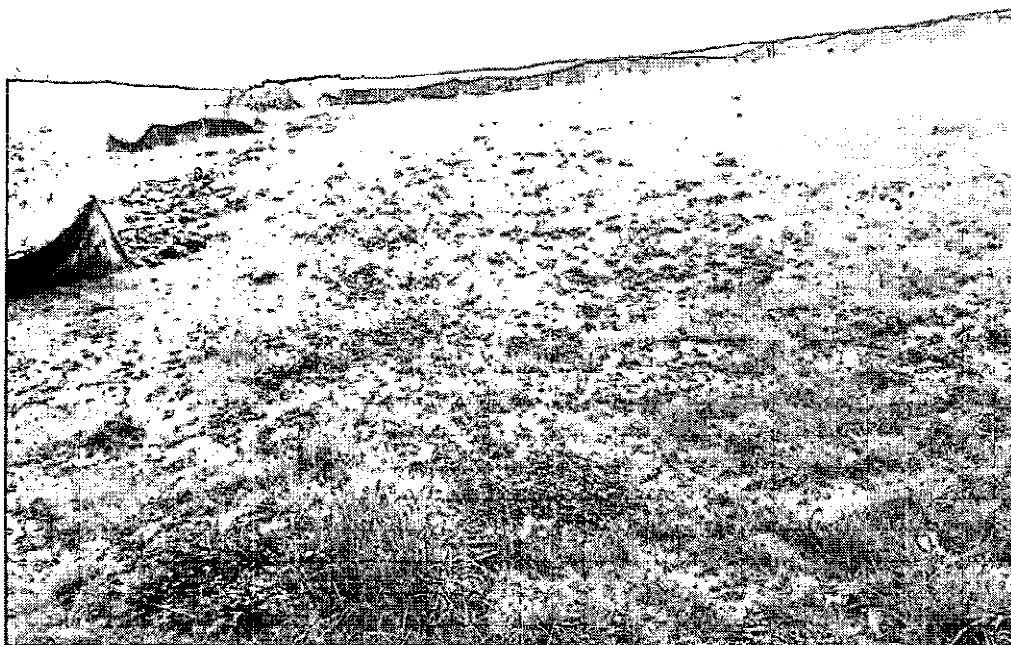
Date: 10/15/2014
Time: 10:49 A.M.
Direction: North
Photo by: Jeff Turner
Exposure #: 008
Comments: Exposed
culvert in main
runoff collection
area

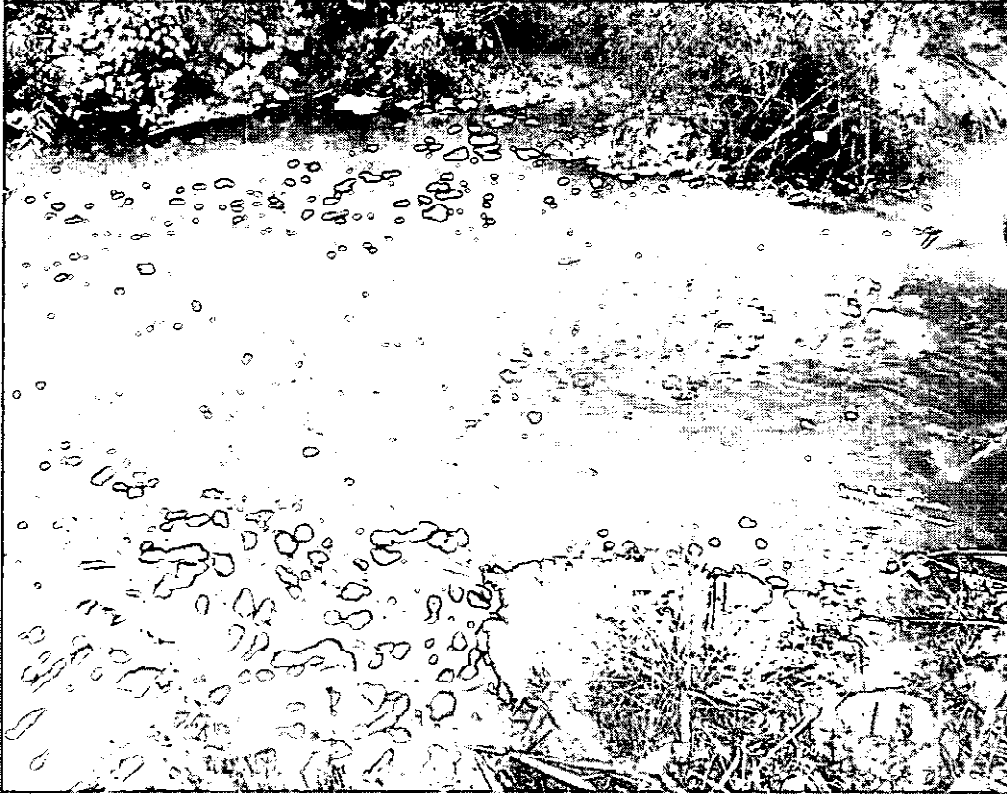
Date: 10/15/2014
Time: 10:51 A.M.
Direction: South
Photo by: Jeff Turner
Exposure #: 009
Comments: Receiving
pool at head of
ravine

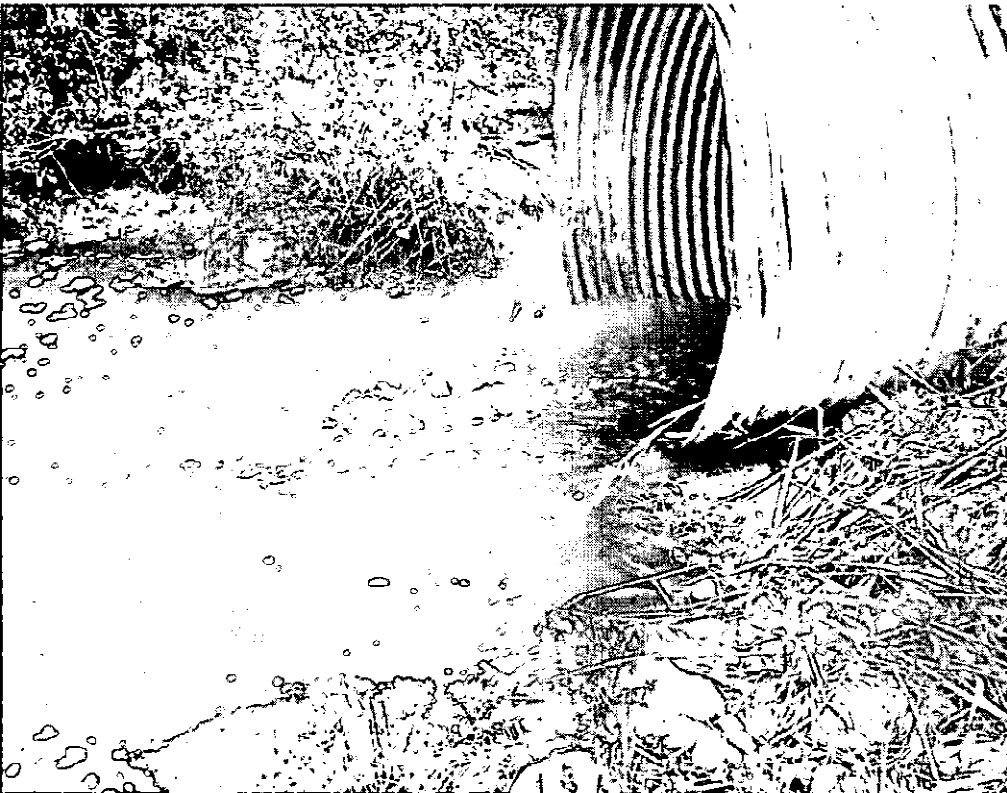
Date: 10/15/2014
Time: 10:51 A.M.
Direction: South
Photo by: Jeff Turner
Exposure #: 010
Comments: Receiving
pool at head of
ravine

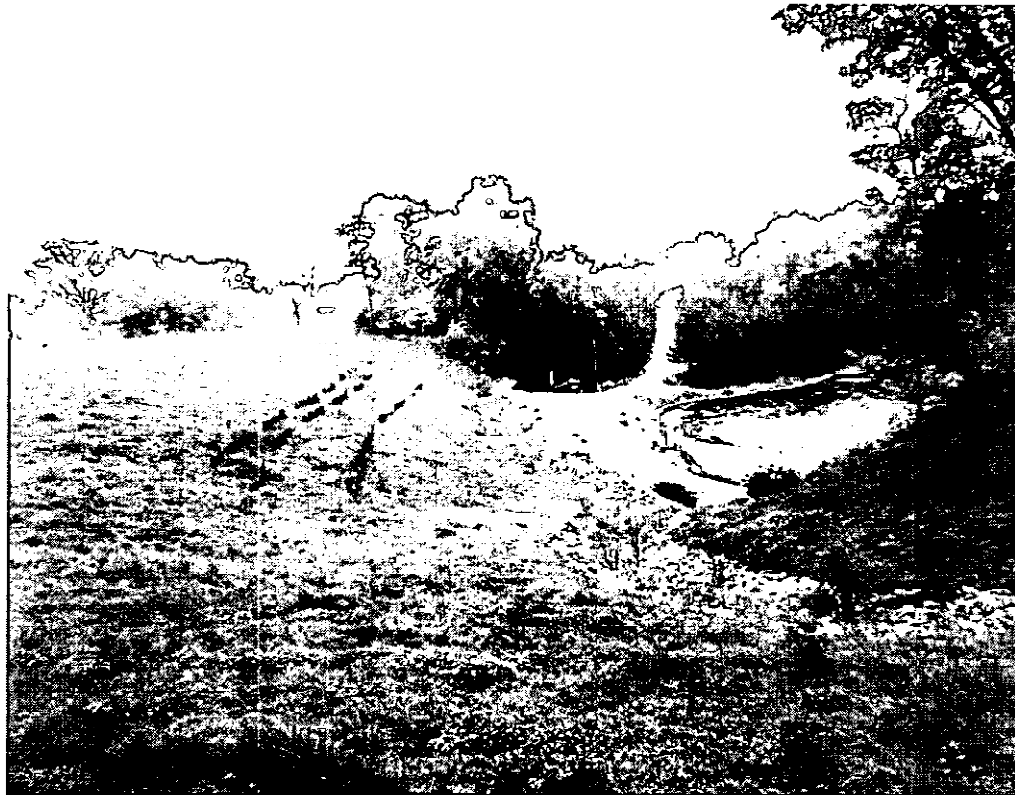
Date: 10/15/2014
Time: 11:02 A.M.
Direction: South
Photo by: Jeff Turner
Exposure #: 013
Comments: Sideslope
on west side

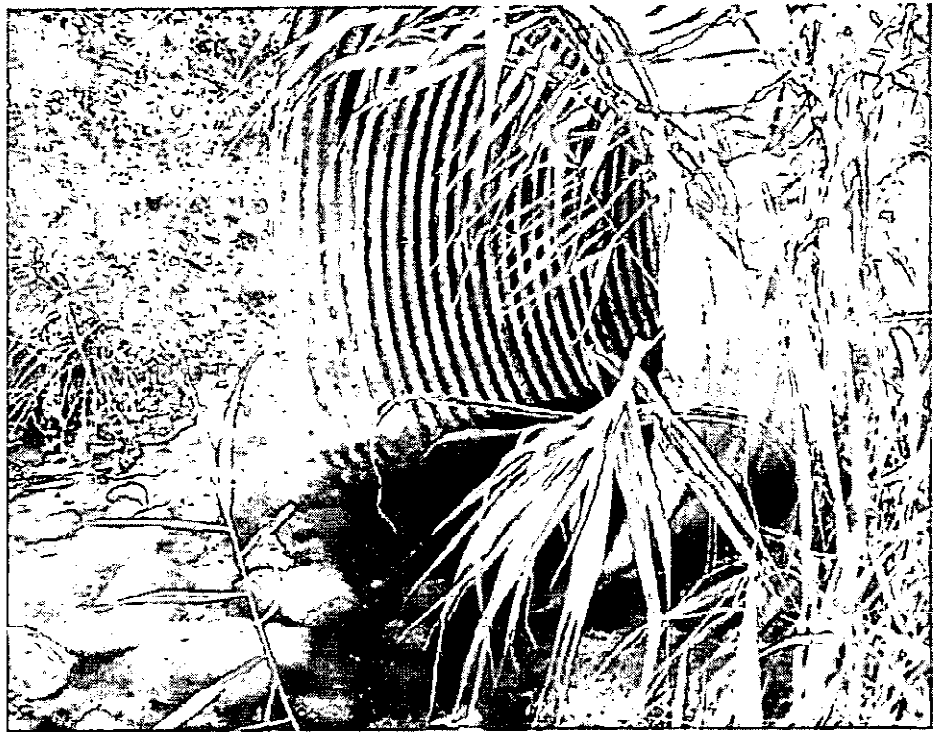
Photograph 3
Looking southwest at a
36-inch culvert that
routes water from the soil
cover and water from a
private pond west of the
site to a pool that feeds
the ravine
