# Evaluation of Public Safety at Run-of-River Dams

### 4.7.4 Sears Dam

The following section includes a description of the existing conditions of and proposed structural options for Sears Dam.

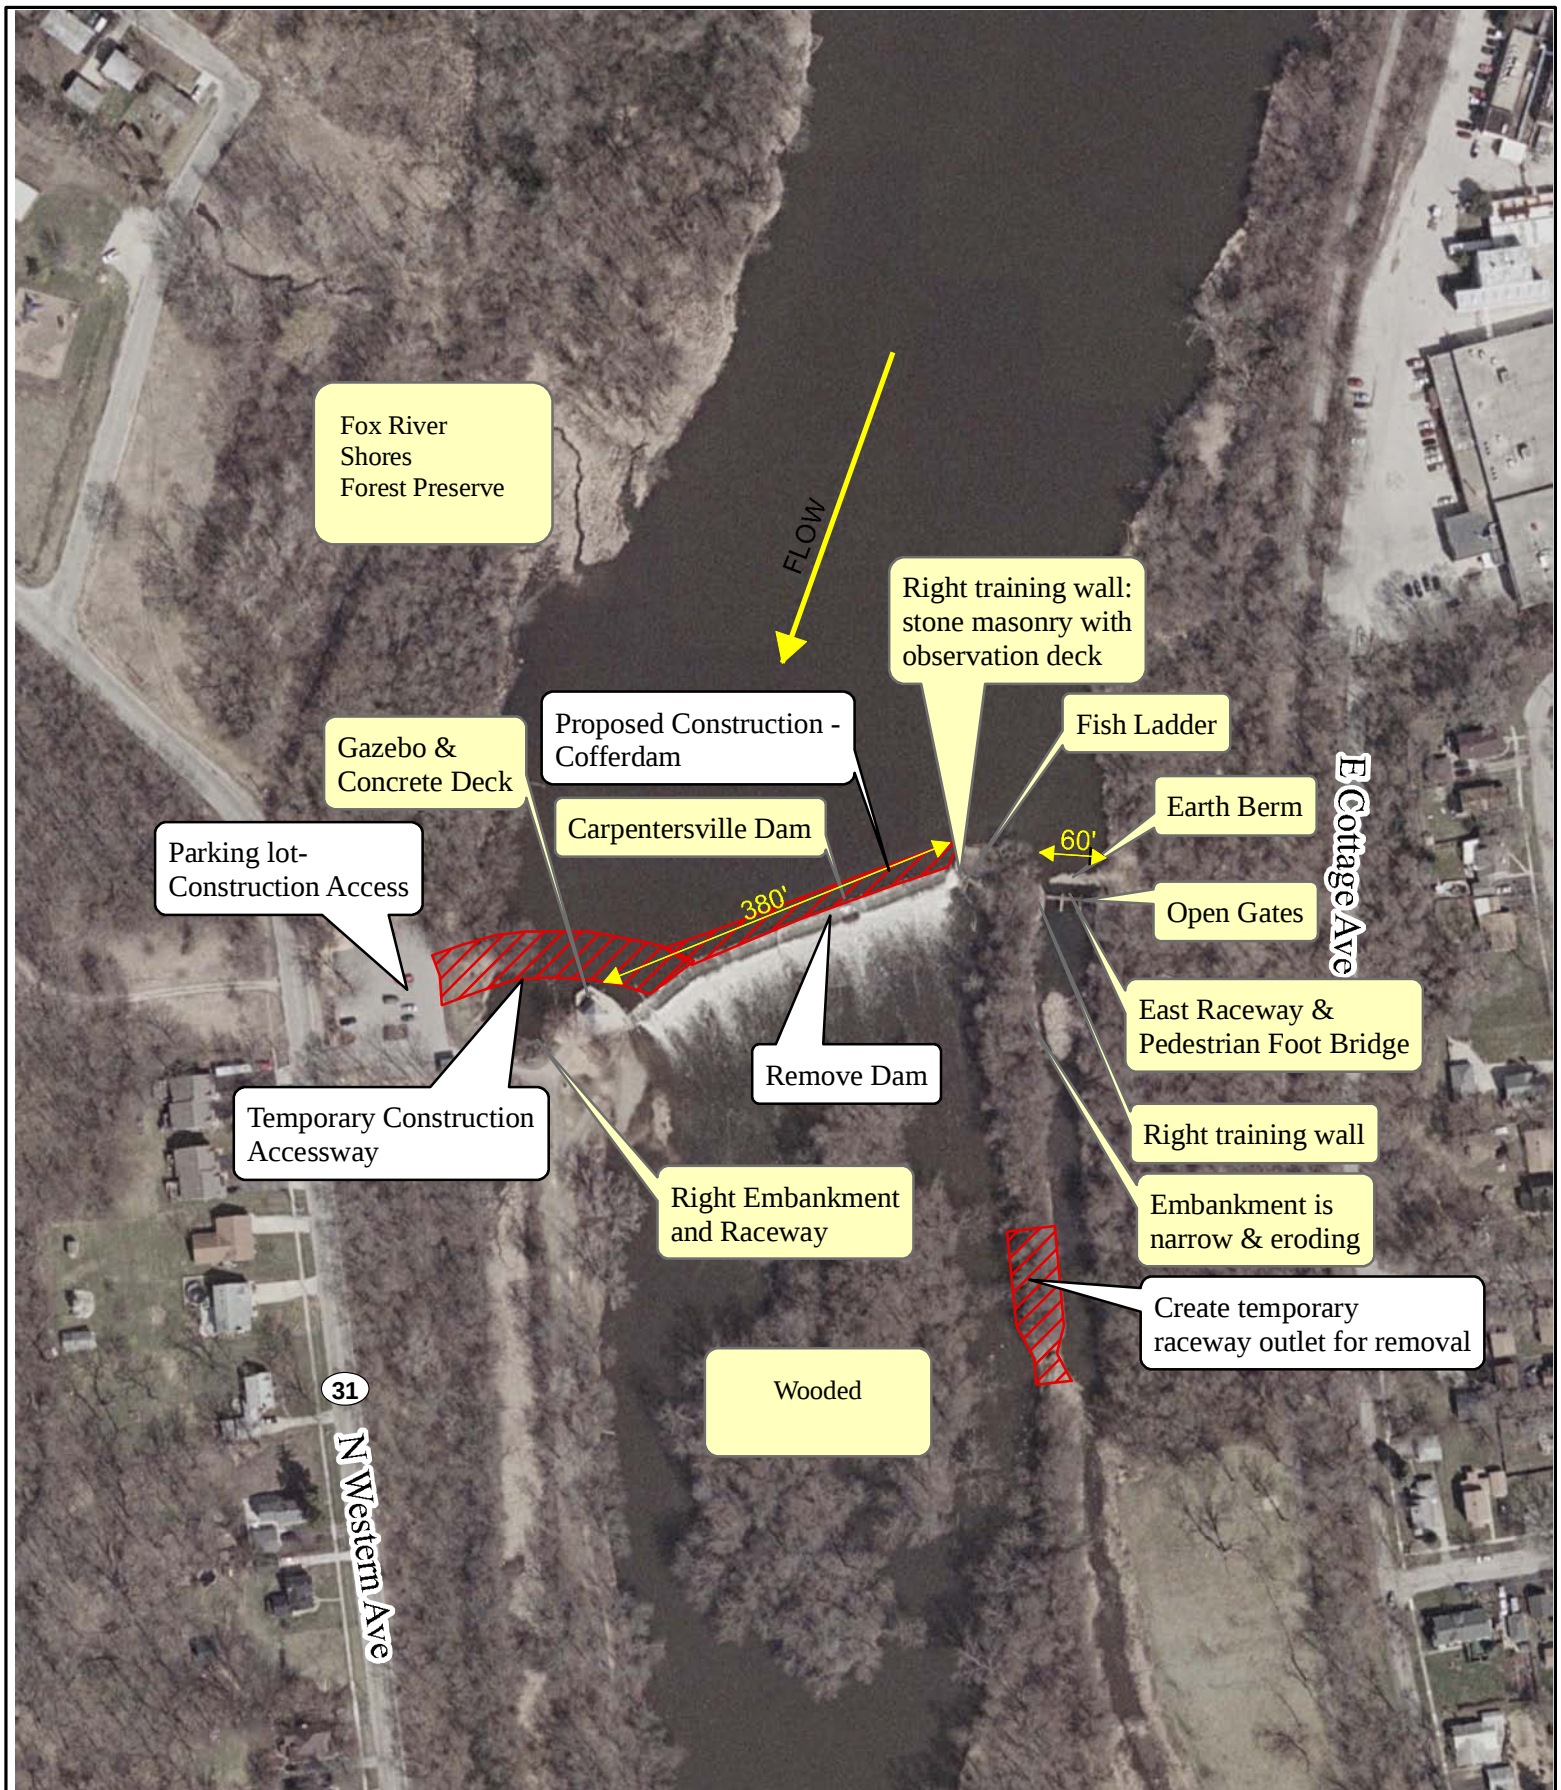
The spillway's left training wall is constructed of stone masonry. The 75-ft long left embankment between the left training wall and east raceway is in poor condition and appears to have been overtopped in the past. Erosion is present behind the downstream training wall, with severe erosion of the left downstream bank due to an eddy. The fish ladder is blocked with debris. The embankment between the raceway and river is narrow and eroding, prone to failure. The right abutment appears to have some undercutting downstream of the abutment. Raceway head gates are three 12-ft high concrete bays, with a total width of 60 ft. Heavy duty timber stop logs plug the raceway, holding approximately seven ft of water. An earth berm (old cofferdam) crosses most of the east (left) raceway, just upstream of the head gates.

The right abutment has some undercutting at the downstream ft of the abutment. Log debris on the dam face near the right abutment was noted. The left abutment is in deteriorating condition with cracks and some vegetation growth in abutment. There is erosion around the left abutment. The fish ladder located at the left abutment showed some concrete deterioration and was partially clogged with log debris. Significant erosion was noted on the downstream left bank. There is a millrace left of the left dam abutment that has been bulkheaded to prevent flow. Some overflow could occur at exceptionally high river levels. There is a pedestrian walkway over the millrace that is in poor condition. This walkway is the access to the left abutment.

The right raceway could, with minor improvements, be used to divert water from the spillway. It could be temporarily reconnected to the river just below the dam. The left raceway appears to have significant flow capacity and could be the prime water control system. Removing the flashboards and bulkheads gradually would provide a controlled drawdown to minimize the extent of needed cofferdams and sediment control costs during construction. Favorable access to both ends of the dam and easy drawdown conditions would enable a relatively easy removal.

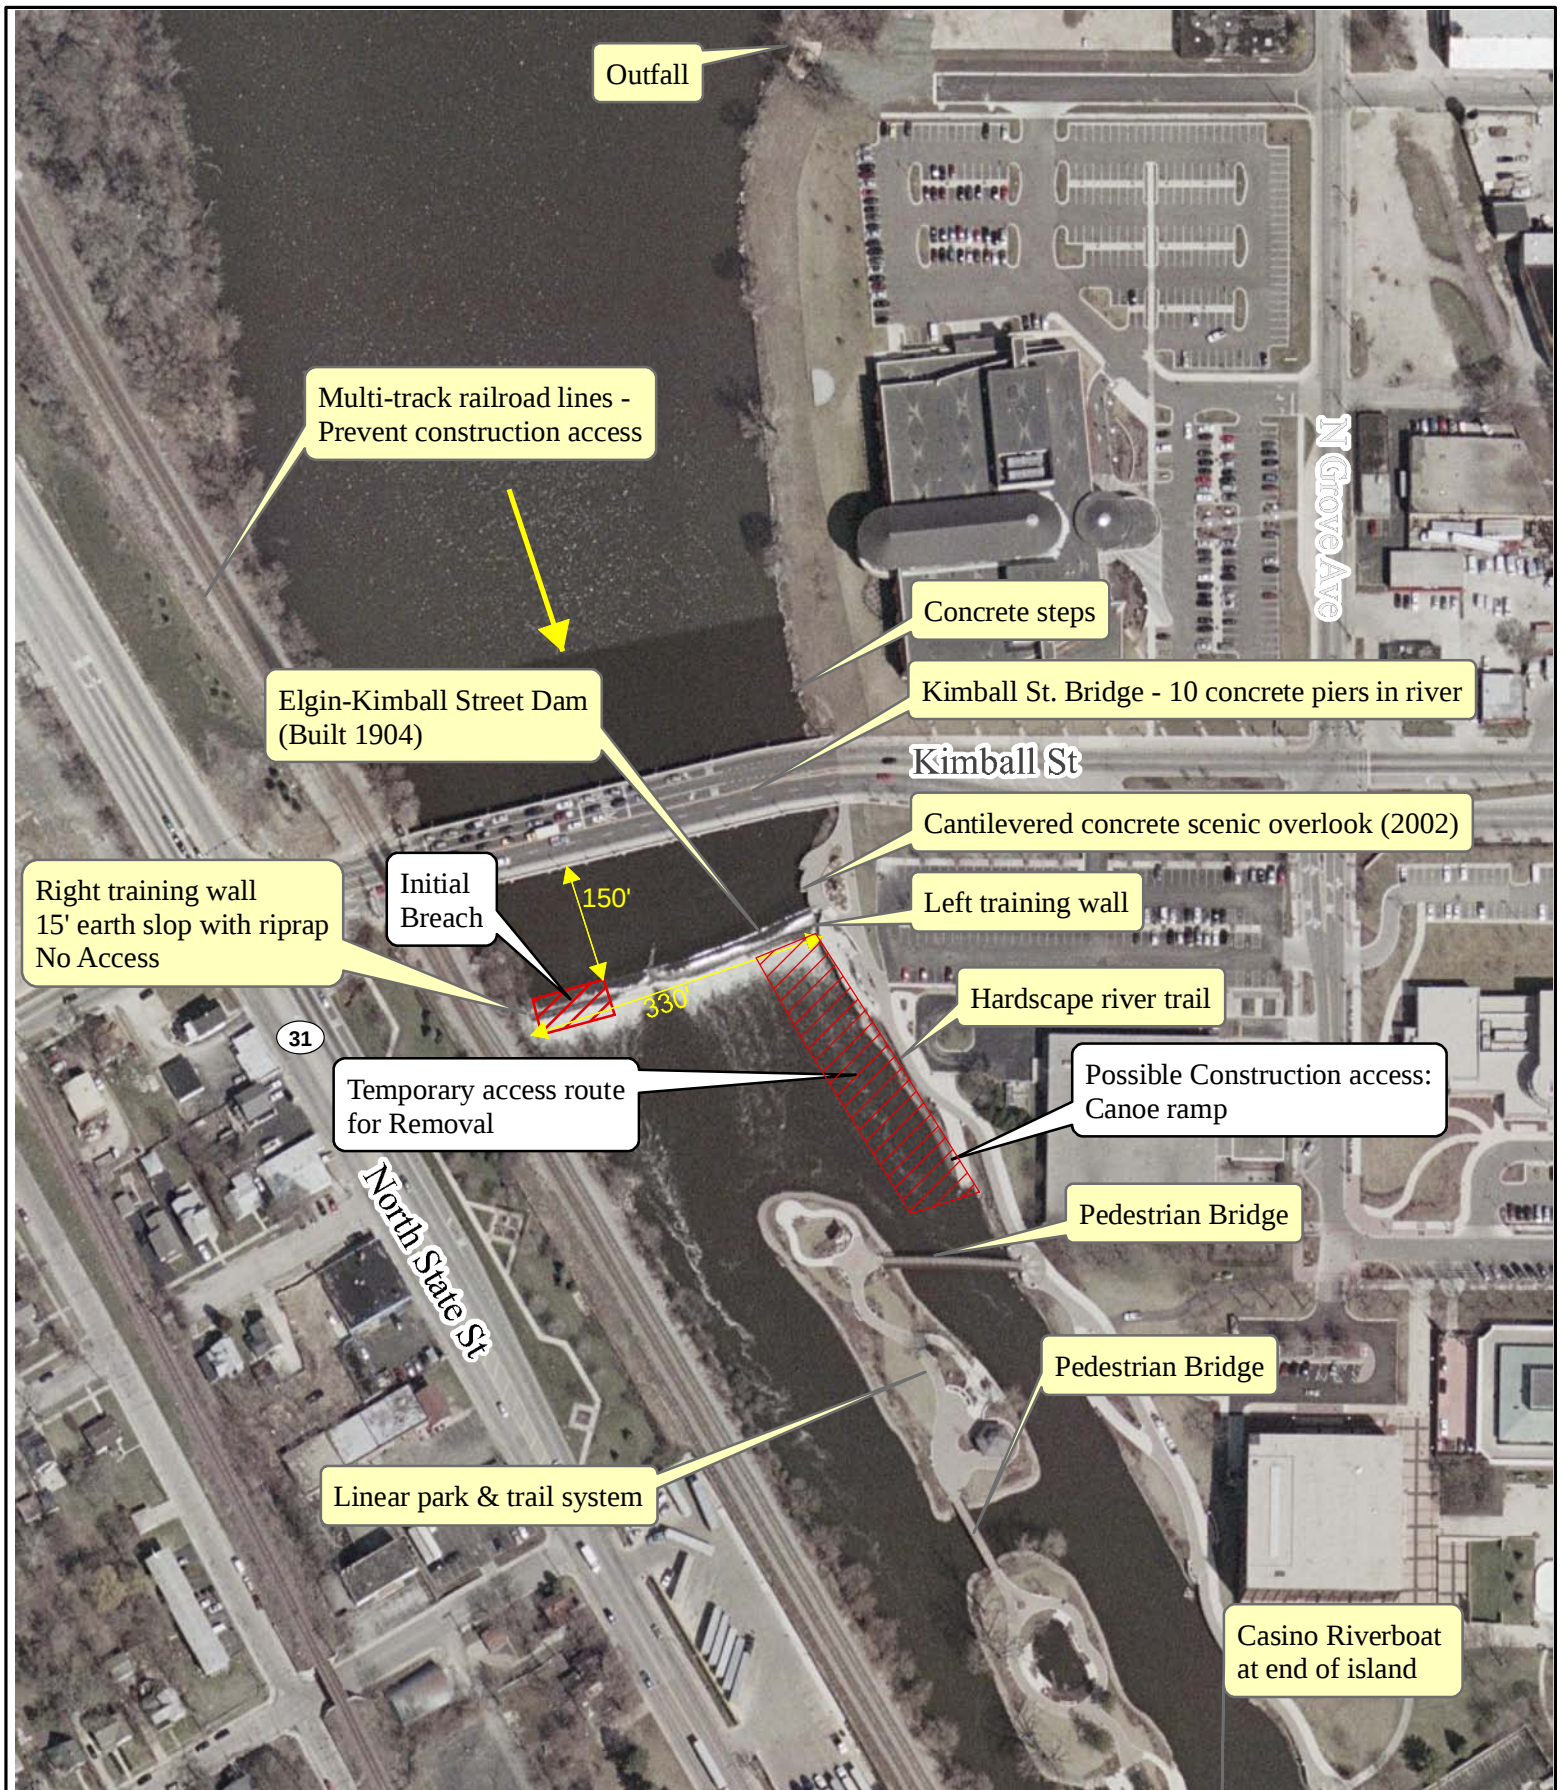
Low velocity flow rates between the dam and island attest to deep water depths that contribute to the hydraulic jump. The slightly curved spillway also tends to push water towards the banks, not the river's center. Raising the concrete apron or decreasing tailwater levels could provide relief from the hazardous conditions.

- g) This structure is massive and will require an extensive amount of demolition. Removal is likely to be expensive.
