ILLINOIS ENVIRONMENTAL PROTECTION AGENCY

Memorandum

Investigation of Sediment in an Unnamed Tributary to Middle Fork Vermilion River

April 26 through May 12, 2016

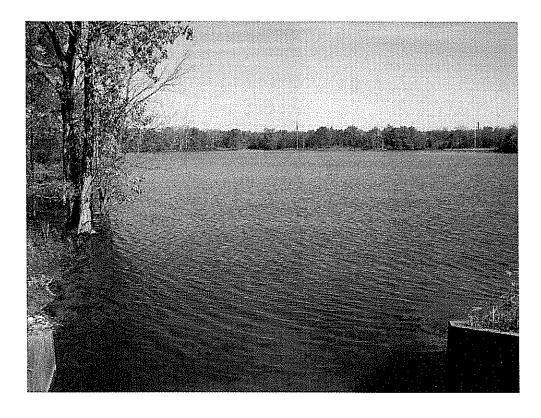
I donned steel toed shoes, zipper-front Tyvek coveralls, and an orange vest. We applied insect repellent to protect against ticks and mosquitos. We drove to the location of the reservoir spillway where I took pictures of the water in the reservoir and the spillway (photographs 1-3). The discharge over the spillway was clear and shallow.

Photograph 1 Looking northwest from the bridge over the reservoir

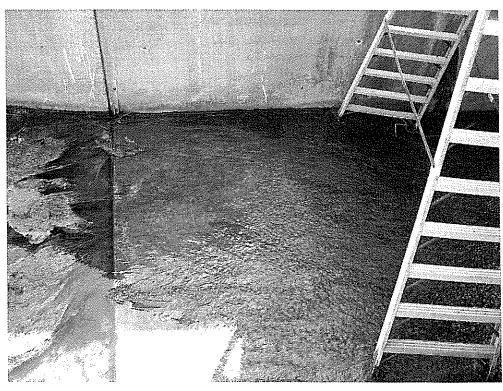
Photograph 2 Looking southeast and down at the spillway that is Outfall 002

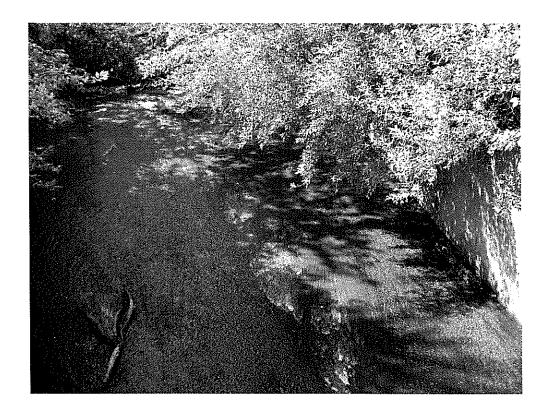
Photograph 3 Looking south at the stream below the spillway

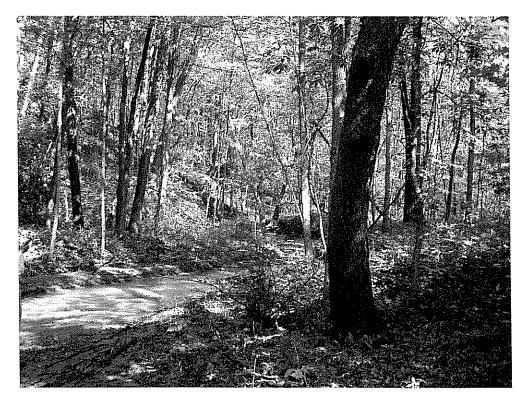
We drove to the location labeled Start in Figure 4. From there we began walking southwest, hoping to find the confluence of the Dynegy flow with the unnamed tributary to the Middle Fork. We descended into steep valleys with streams at the bottom at least twice. Photographs 4-7 show sections of the first stream we crossed.

Photograph 4
Looking north at flow in the first stream we encountered (~35 minutes into our walk) while attempting to find the intersection of the Dynegy stream with the large unnamed tributary to the Middle Fork

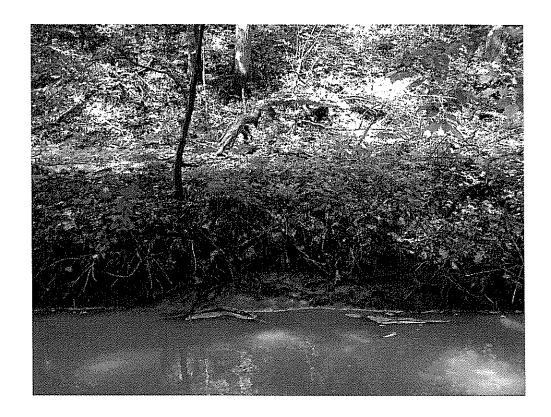
Photograph 5 Looking west across the stream shown in photograph 4

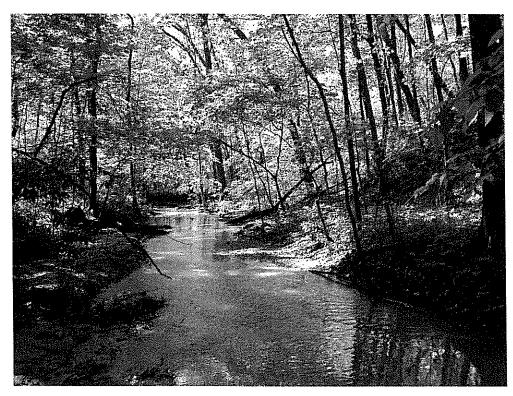
Photograph 6 Looking downstream in the waterway shown in photographs 4 and 5

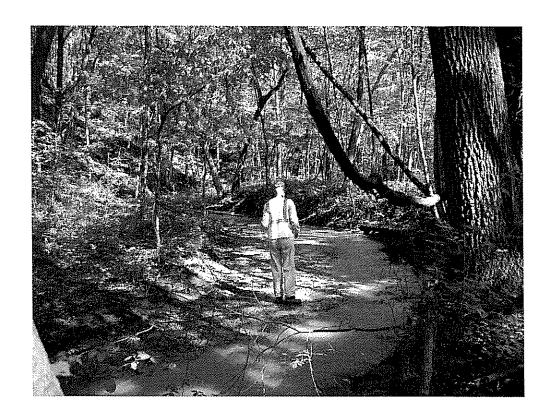
Photograph 7 Looking north at the same stream shown in photographs 4-6, Rick Diericx is shown looking upstream

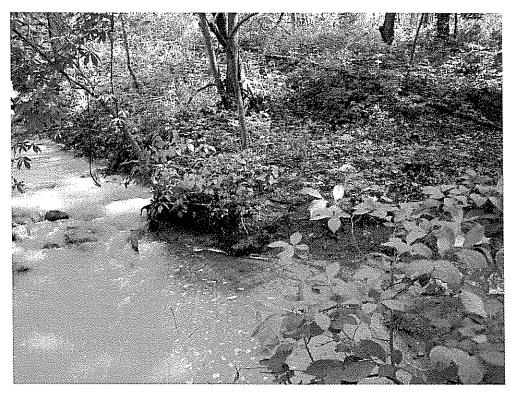
After about 75 minutes we reached a location close to where I placed a white star on the map in Figure 4. (I had a GPS with me, but the readings were not consistent because of the tree canopy and the batteries were running low.) The channel from the reservoir ranged 6-12 feet wide. The flow was rapid with several sections of whitewater where it flowed over rocks. We were not able to cross the stream and it did not appear that we could reach the confluence without descending and climbing at least one more hill. We decided to follow the channel northwest to the spillway. All along the way, the water was turbid and a light brown color (photographs 8-12. When I located the spillway, I took photographs 13-14.

Photograph 8 This is the spillway stream

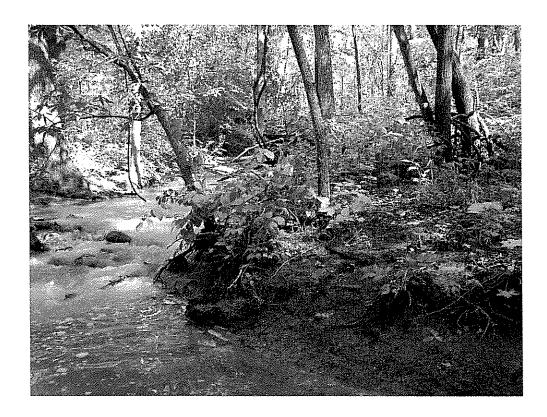
Photograph 9
Another view of the spillway stream with whitewater over the rocks

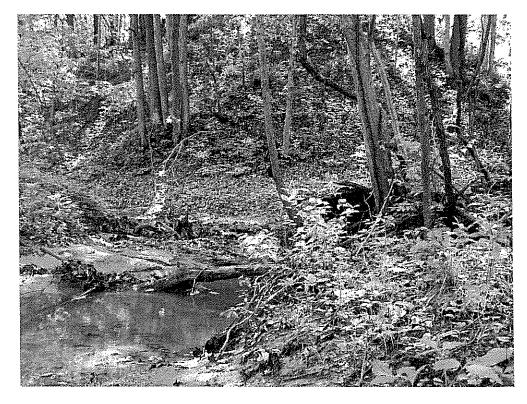
Photograph 10 This is a side stream of the spillway stream that flowed mores slowly through a low area and rejoind the main channel

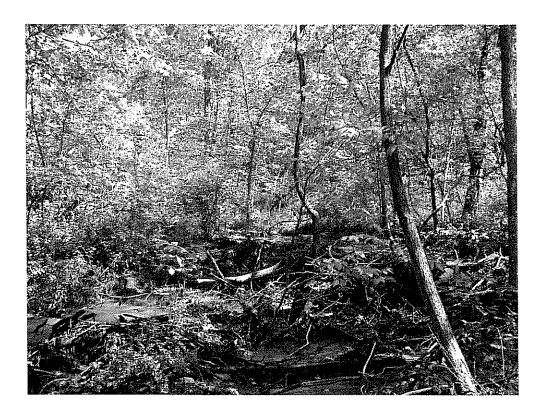
Photograph 11 A location in he spillway stream with several logjams

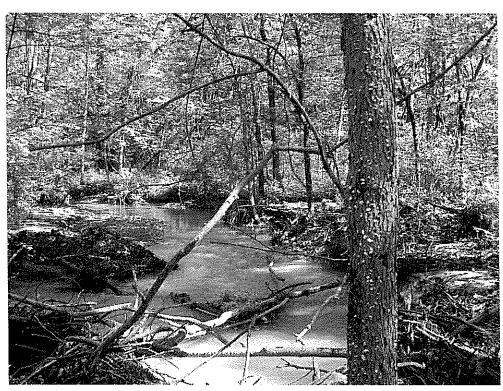
Photograph 12 This photograph was taken at bend in the spillway stream

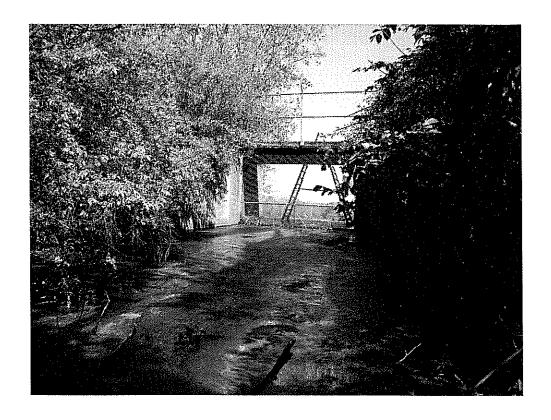
Photograph 13 Looking north at the bridge and the spillway downstream of the location in photograph 2

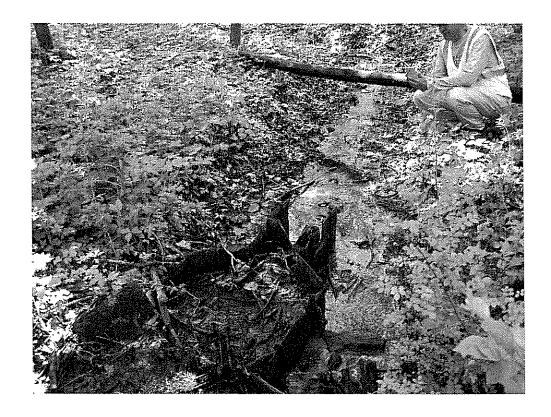
My legs were getting weak and I felt dehydrated, soI told Mr. Diericx that we should return to the vehicle. We began walking almost parallel to the fence that runs along the south side of the reservoir and returned to the starting point. About halfway back, we found a v-notch weir (Photograph 15) that could have been used to monitor flow at some point.

Photograph 15 Looking south at a Vnotch weir
