**Re: Vermilion Site
MFV Riverbank Assessment Report**

**Vermilion Site Riverbank
Assessment**

Prepared for:
Dynegy Midwest Generation, LLC

Prepared by:
Stantec Consulting Services Inc.

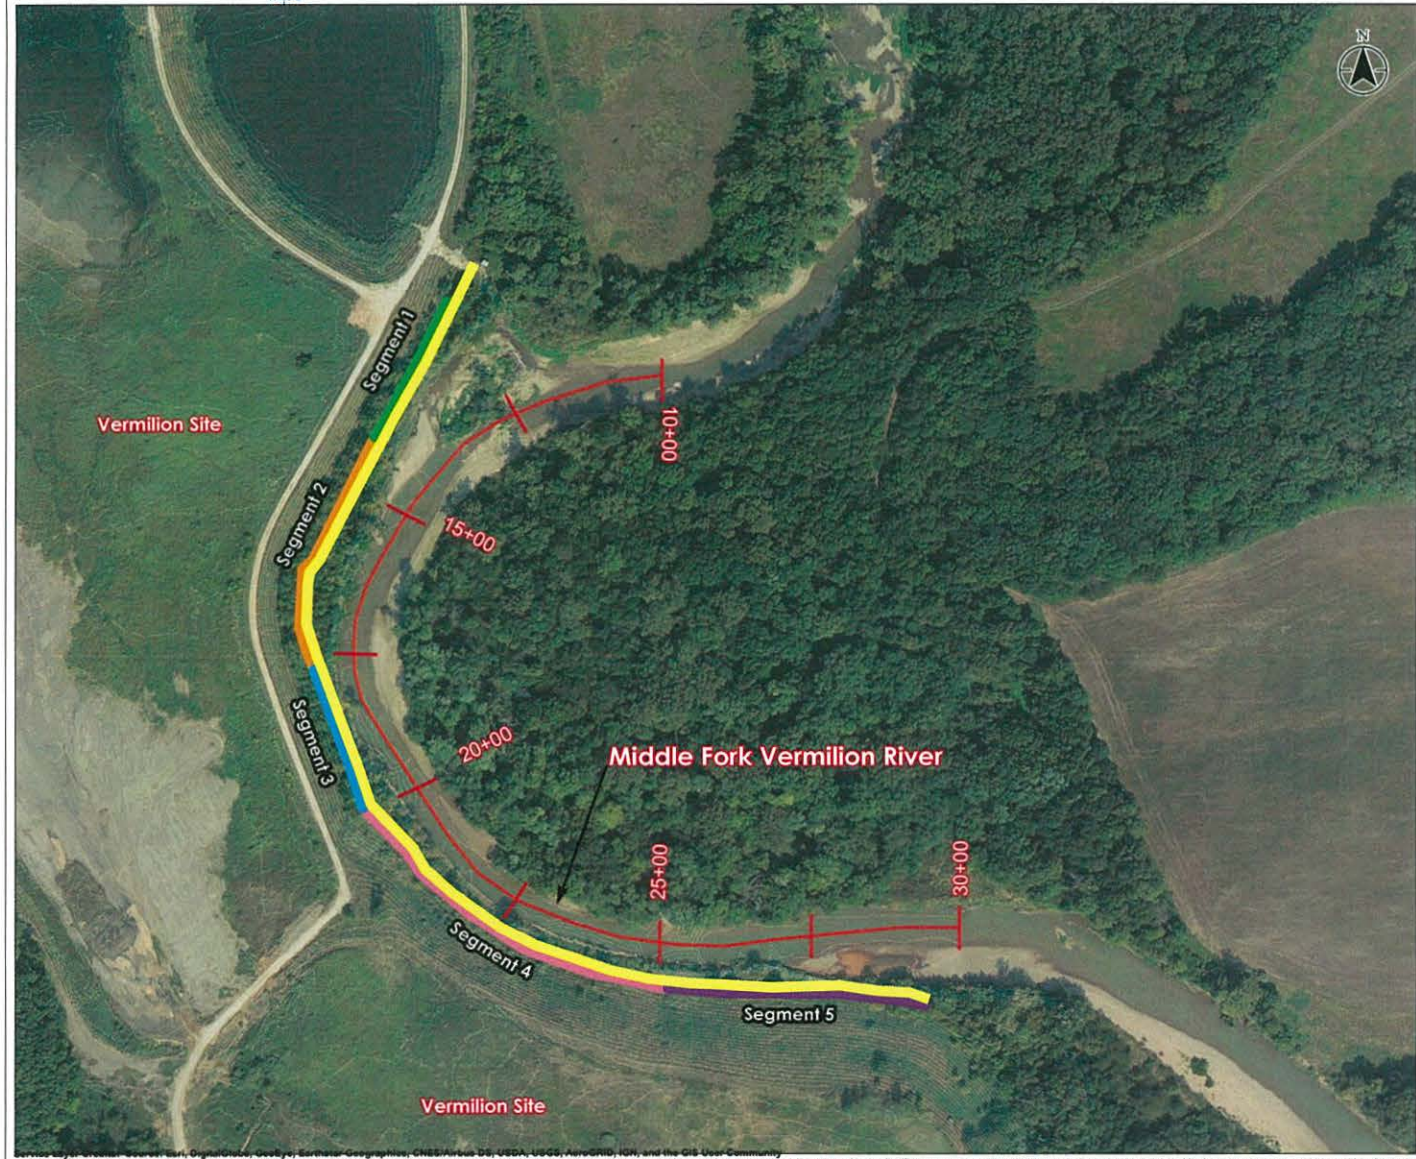
Title
Attachment 1 - Current Conditions

Riverbank erosion was evident along the right and left descending banks adjacent to the DMG Vermilion Site. The sediment supply of the Middle Fork appears to be moderate to high with point-, mid-channel- and side-channel bars observed. This sediment supply likely contributes to riverbank erosion especially during high water conditions. The vegetation communities along the five riverbank segments were inconsistent, with herbaceous, shrub, and forested portions observed. Segments with vegetative communities with poor rooting depth and density also contribute to riverbank erosion. Survey data collected (by others), geotechnical boring data along the embankments as well as basic geomorphic data have been collected on site to help prepare this analysis. The existing conditions are summarized below and shown in Attachment 1.

Riverbank segments 1, 3 and 5 have an estimated 15- to 30-foot wide moderately sloping bench that separates the toe of the embankment and the top of the riverbank. Some sections were observed with failing gabion baskets while others were simply eroded, near vertical, riverbanks.

Riverbank segment 2 has an estimated 30- to 72-foot-wide, gradually sloping bench that separates the toe of the embankment and the top of the riverbank.

The line of demarcation between the Middle Fork riverbank and embankment toe was difficult to discern within riverbank segment 4. Deteriorating gabion sections along the riverbank toe were observed along this stretch of the Middle Fork.

Access for inspection and maintenance purposes is limited in select areas, primarily along riverbank segments 1, 3, 4 and 5. As shown in Attachment 1, several areas along riverbank segments 1, 3, 4 and 5 have already crossed the initiation line. The width of remaining bench varies along the riverbank segments between 19 and 72 feet. The average estimated erosion rate of the estimation methods considered was 2.3 feet/year. Using the average erosion/bank retreat rate, it is predicted that the widest bench portions could reach the "initiation line" in 18 years. Some areas currently at or beyond the "initiation line" could have no remaining bench and may erode to the embankment toe in 8 years using the average erosion rate. The stability of the gabion baskets is compromised and it is not possible to reliably predict how long these will continue to function.

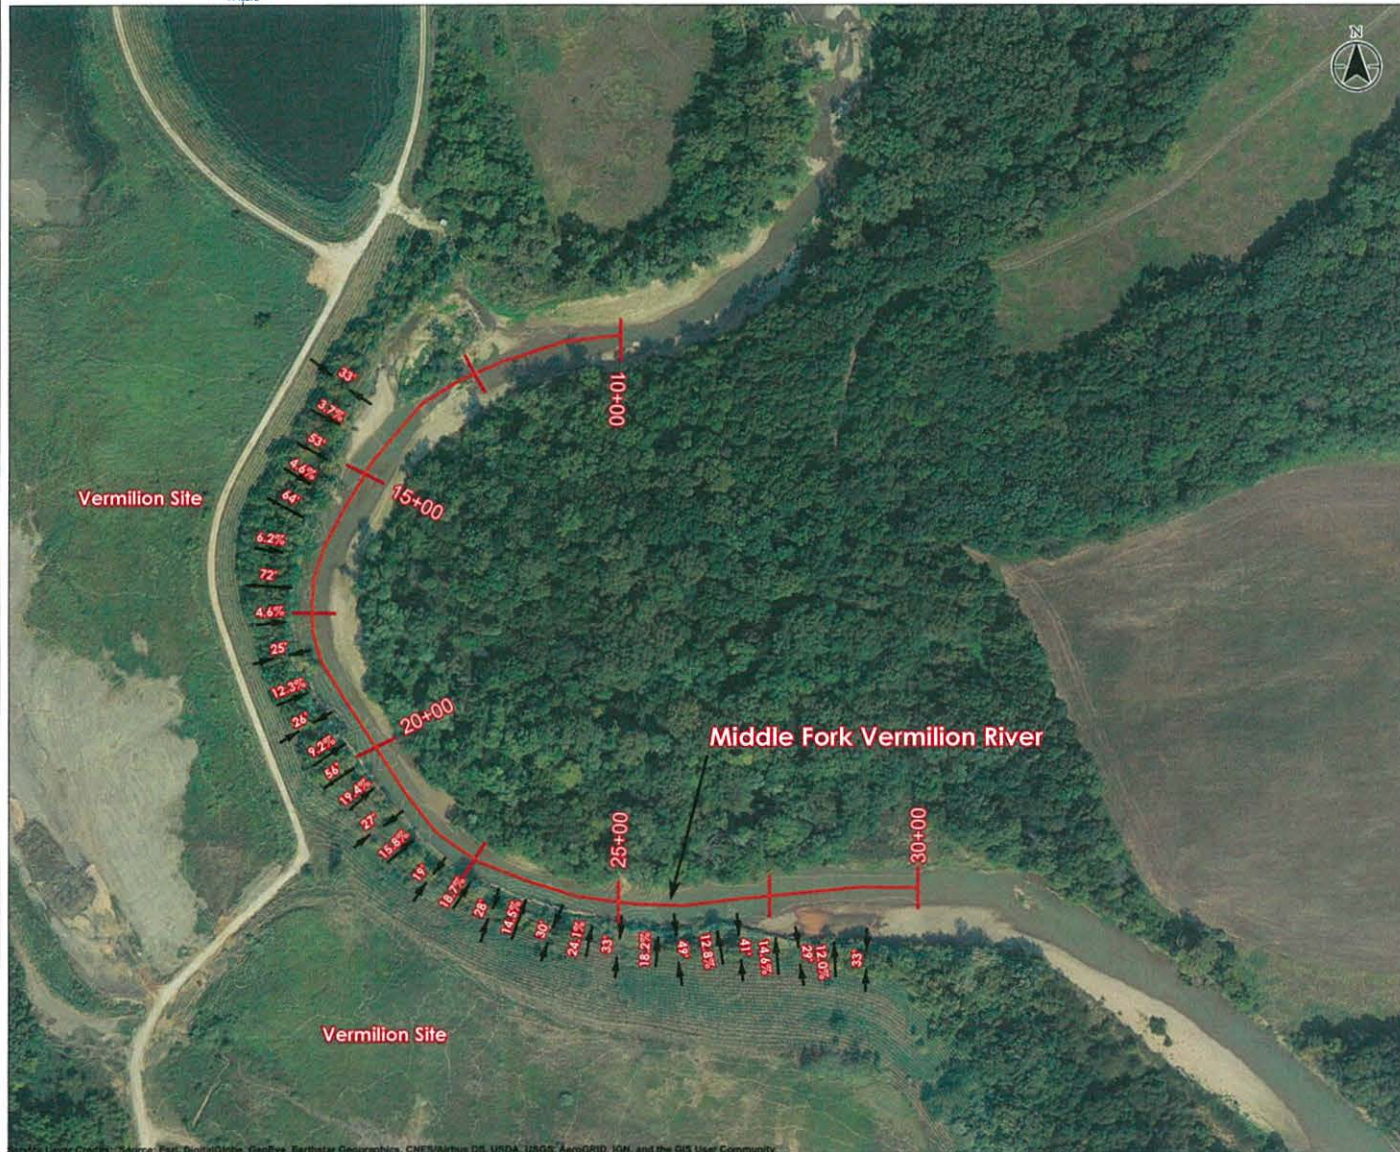
Title
Attachment 2 - Bench Estimates

The access along riverbank segments 1, 3, 4 and 5 will be more challenging. These areas have less than a 19-foot wide bench from the toe of the embankments in some locations. Work performed from the top of the riverbank area would likely require a re-grading of the embankment to provide the 30-foot bench width. Rock Toe with LBL requires an approximate 30-foot wide bench, while the Buried Riprap Trench would require an approximate 30 to 40-foot wide bench. For a track hoe to work from the bench, the slope would need to be flatter than 10:1.

Access and Erosion Rate. Riverbank segments have 19 to 72 feet of bench width remaining. Riverbank segments 1 and 2 have the greatest potential for riverbank erosion. The potential for riverbank erosion is less within riverbank segments 3, 4 and 5. However, stability of the gabion baskets within riverbank segments 3, 4 and 5 have degraded whereas they are no longer able to reliably prevent future erosion. The distance between the riverbank and the embankment toe is generally less than that along riverbank segment 2. Approximately 30 feet of bench width is needed for inspection, maintenance, and construction of bank stabilization measures. Several areas within riverbank segments 1, 3, 4 and 5 already have less than the required bench width, and will require re-grading of the embankment. It is anticipated that all areas within riverbank segments 1 through 5 will have less than 30 feet of bench width in 18 years based on an average of estimated erosion rates. Implementation of riverbank restoration with Option 1 in riverbank segments 1, 3, 4 and 5 will increase bench width and, with proper maintenance, comprehensively extend the life of the bench width.
