Middle Fork Vermilion River Stabilization of the Right Descending Bank at Approximate River Mile 36.2 Nationwide Permit #13; LRL-2008-1366-lcl <u>Project Completion Report</u>

Project Completion Report

DYNEGY MIDWEST GENERATION, LLC VERMILION SITE OAKWOOD, ILLINOIS

RE: Project Completion Report Dynegy Midwest Generation, LLC - Vermilion Site Oakwood, Illinois SCI No. 2009-3006.35

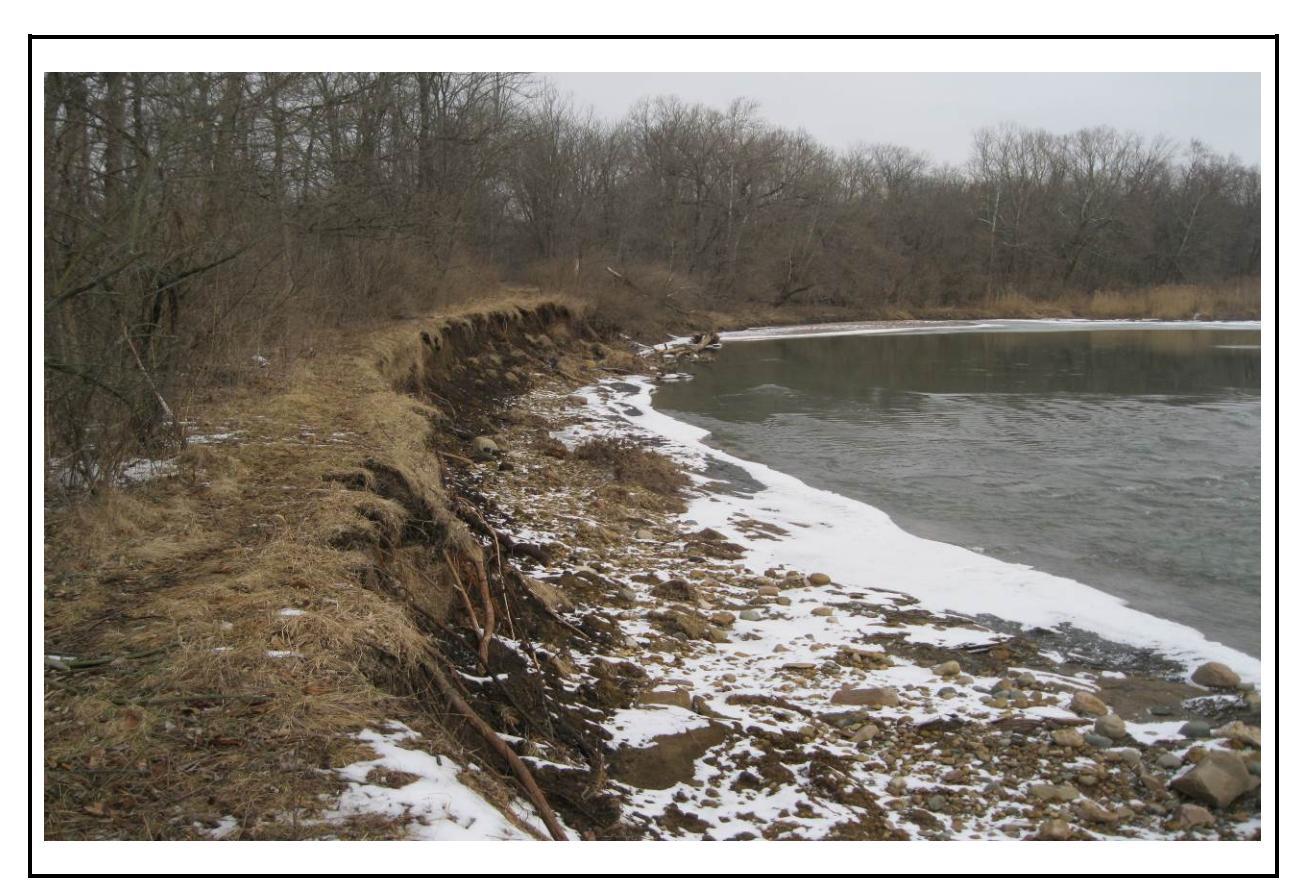
Photo 1. Before construction, looking upstream

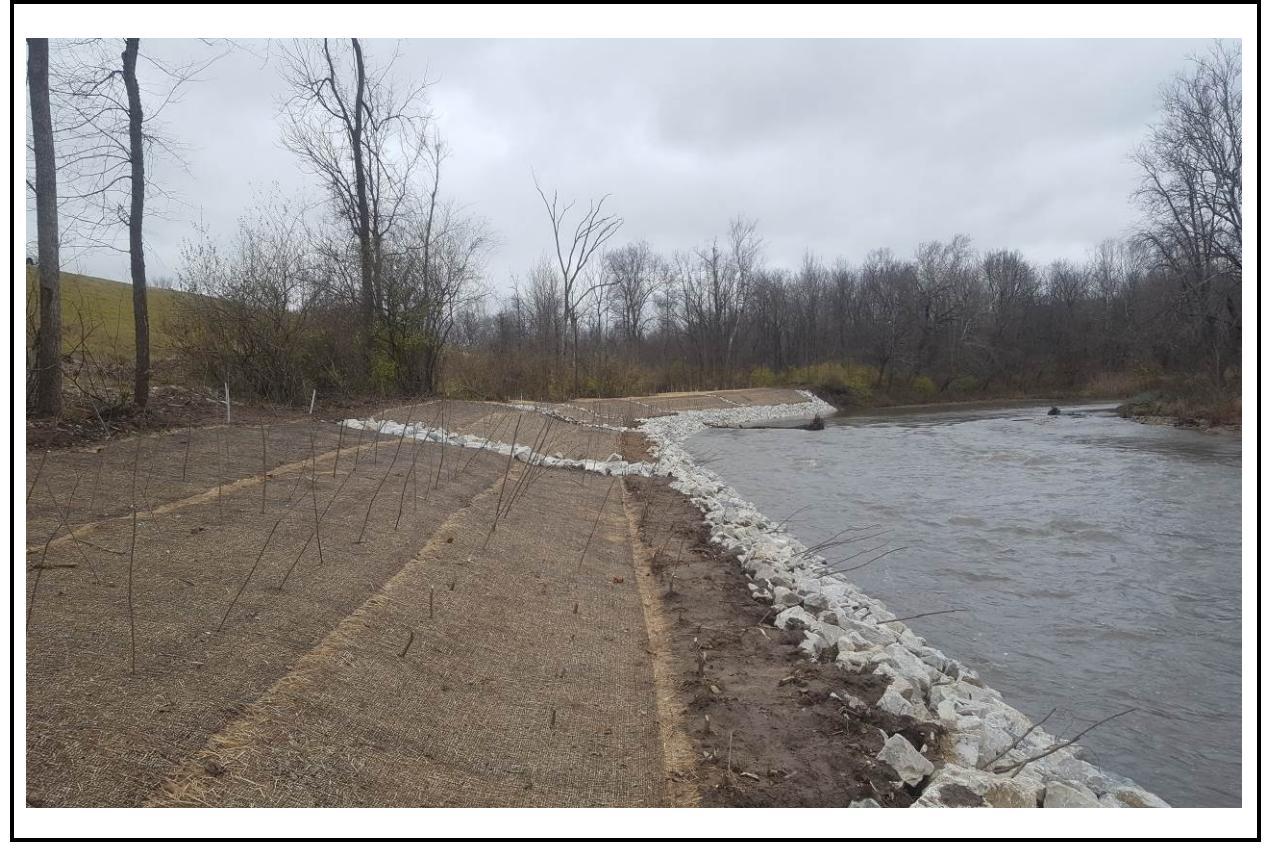
Photo 2. After construction looking upstream

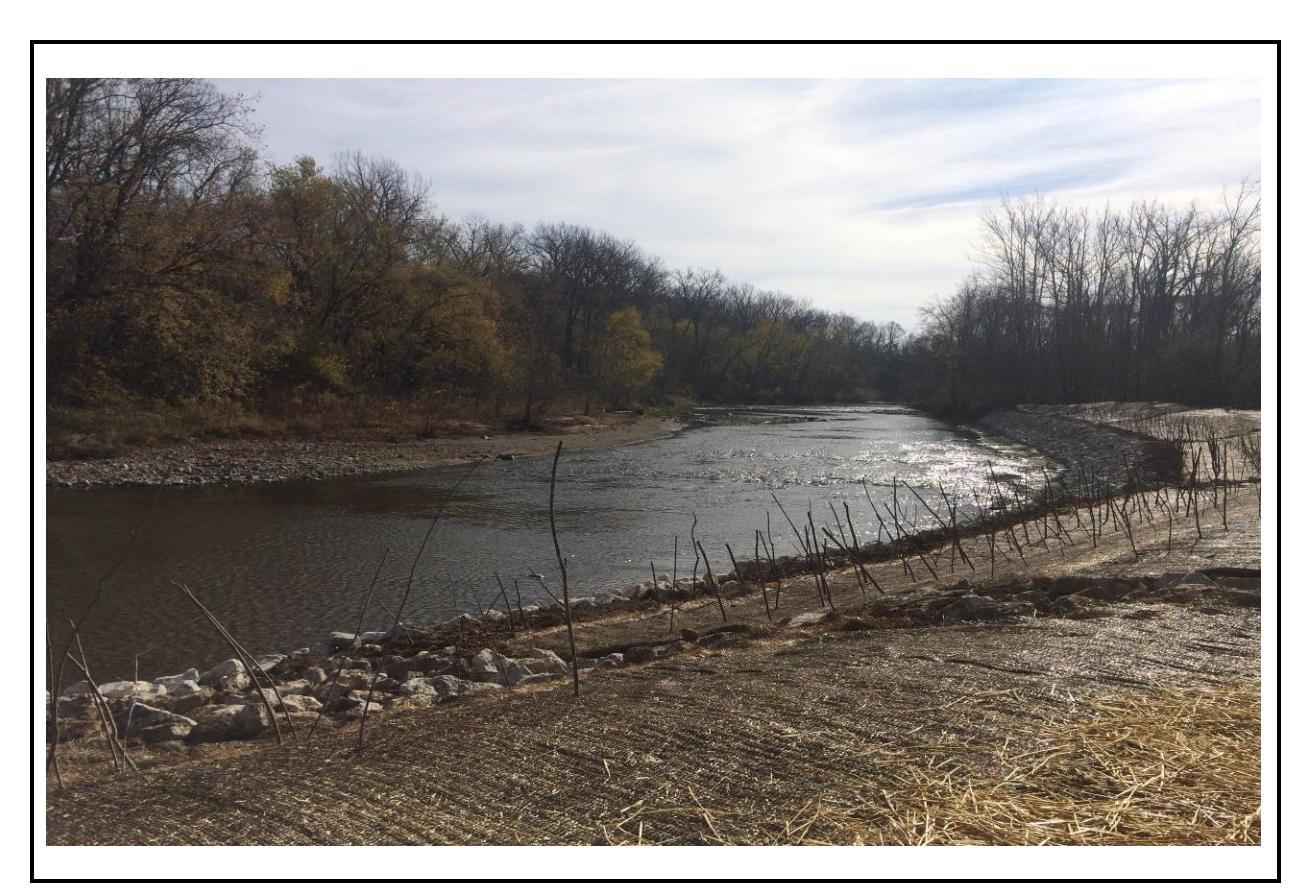
Photo 4. After construction, looking downstream

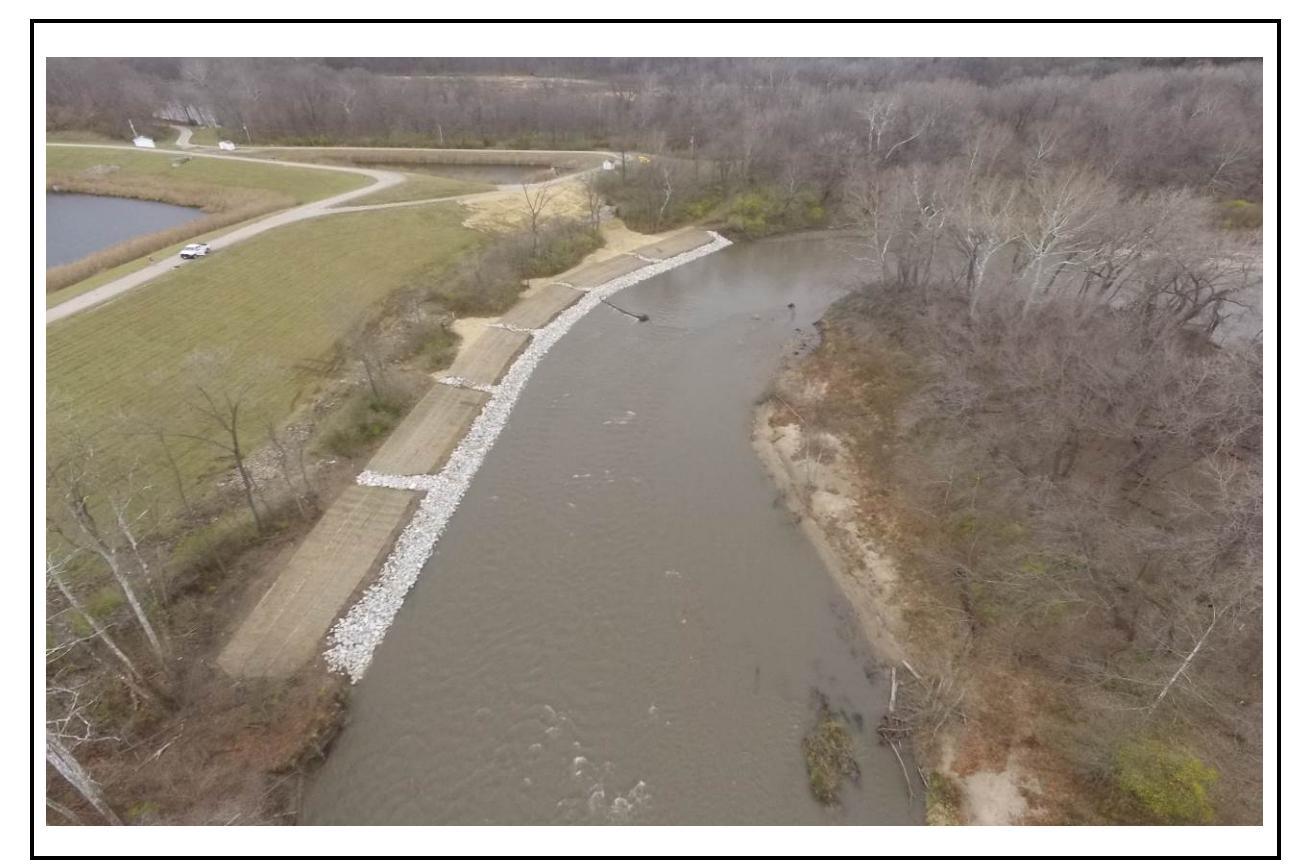
Photo 5. After construction, aerial view

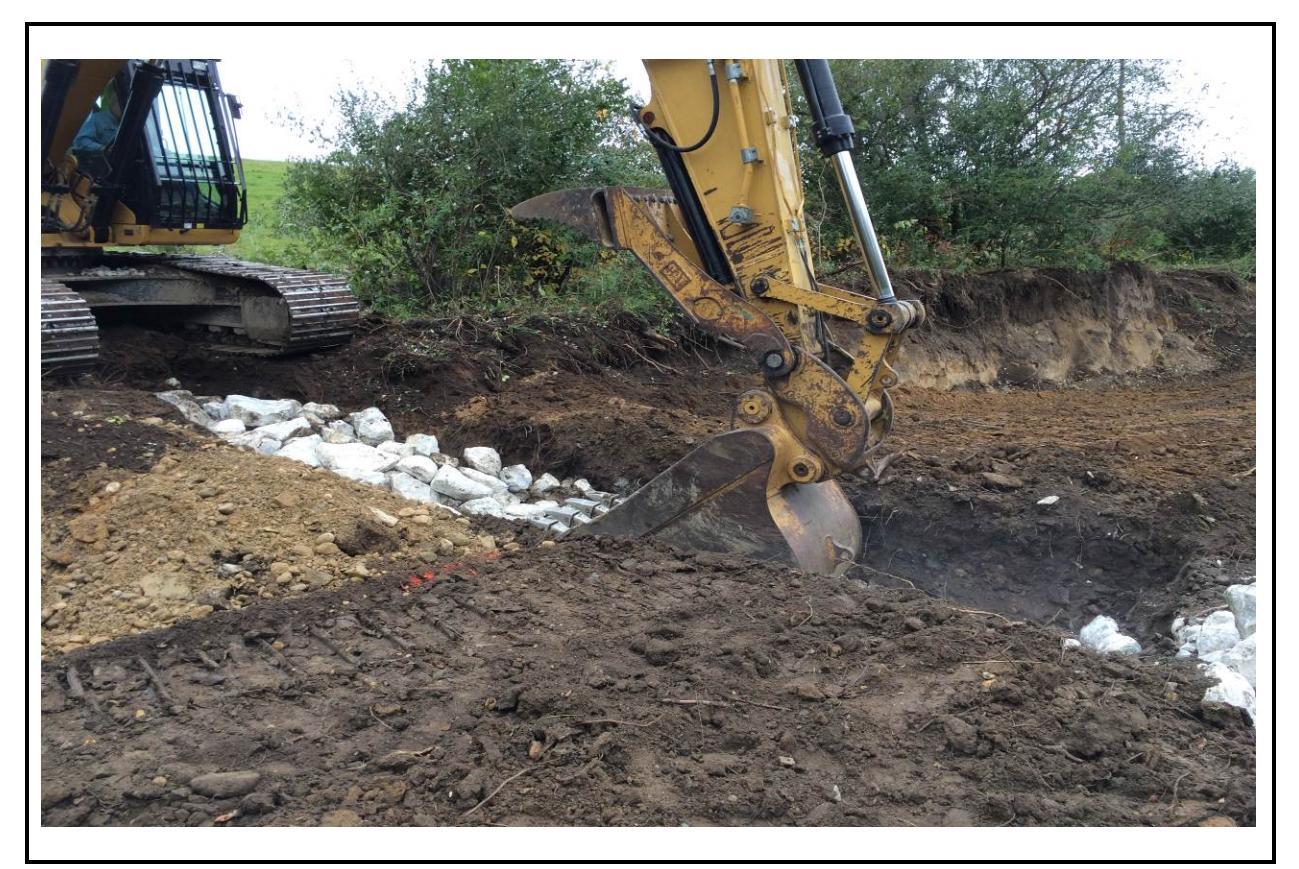
The project consisted of planted longitudinal peak stone toe protection (STP) that was constructed on the shale stream bed and backfilled up to the existing streambank elevation. The STP was placed on the shale channel bed up to an elevation of 576 mean sea level (msl) which was determined to be the ordinary high water mark (OHWM) for this reach of the MFV River (Photo 10). The entire length of the project was constructed from the shale bed or from specific areas directly above the key locations (Photos 13 and 14).

Photo 13. Key Construction from Top of Bank

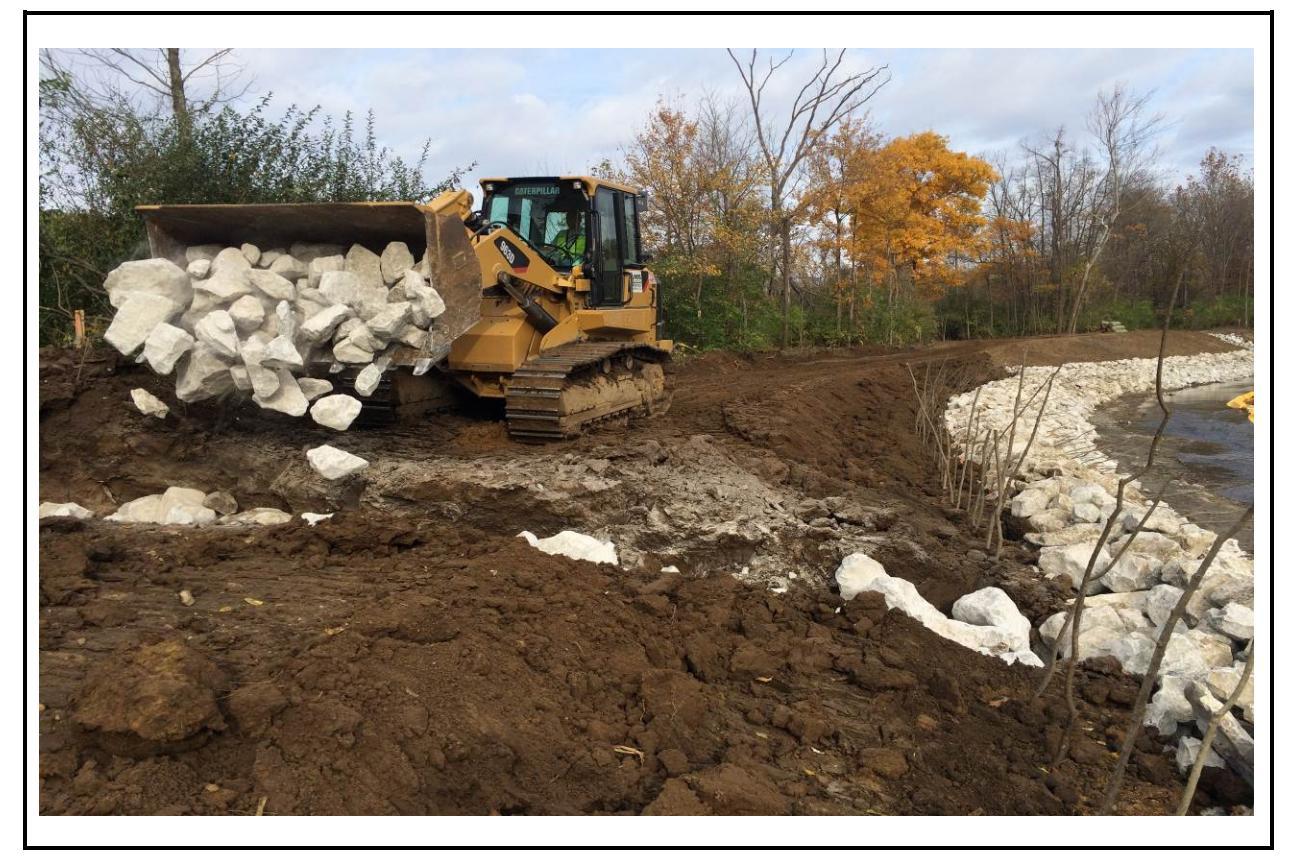
Photo 14. Key construction

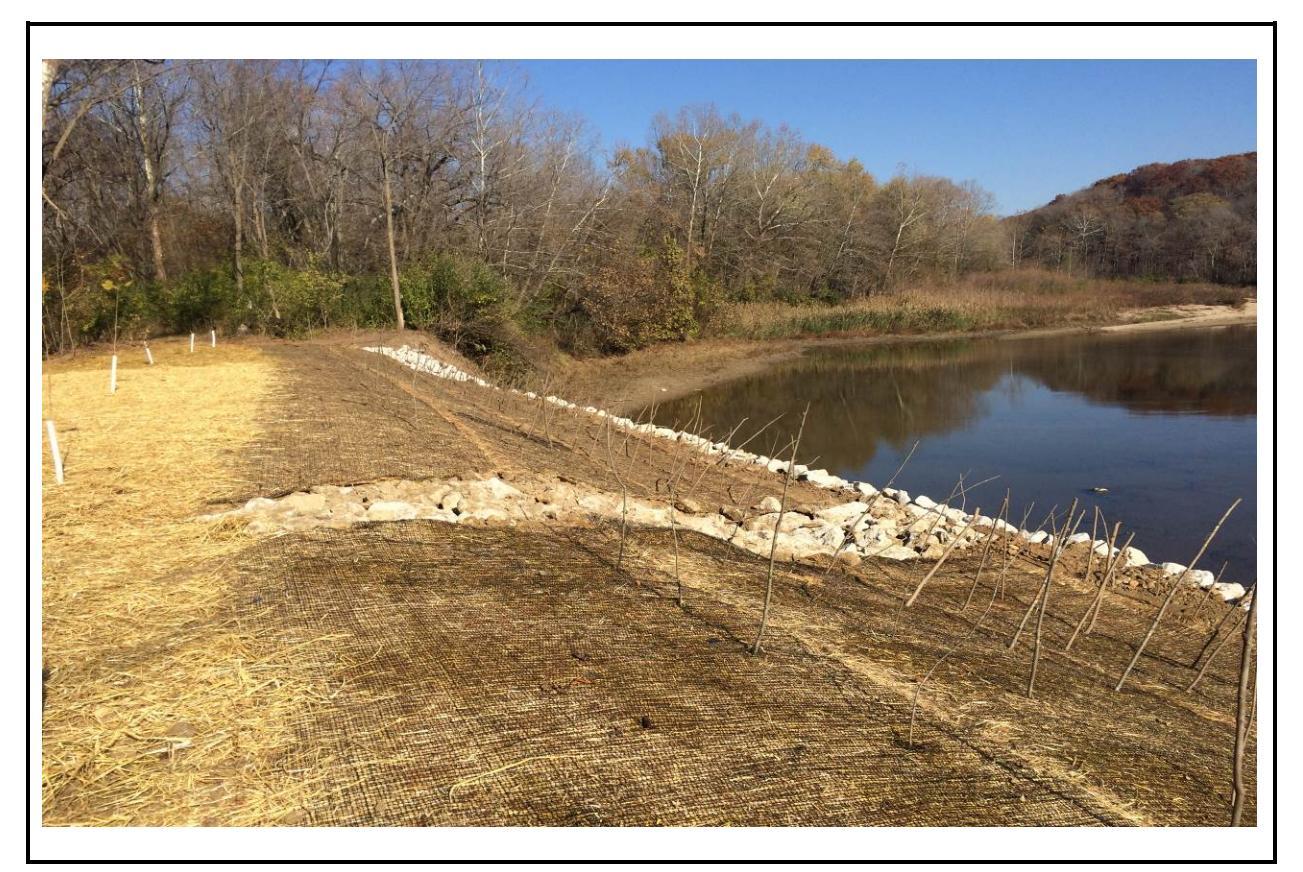
A native seed mix was used to re-seed the top of streambank as well as any other disturbed areas. In addition, winter wheat was included with the mix to provide quick cover establishment. The finished slope was covered with Vmax, SC-250 TRM installed per the manufacturer's recommendation prior to installation of additional poles on the finished slope (Photo 15).

Photo 15. TRM and planted bank

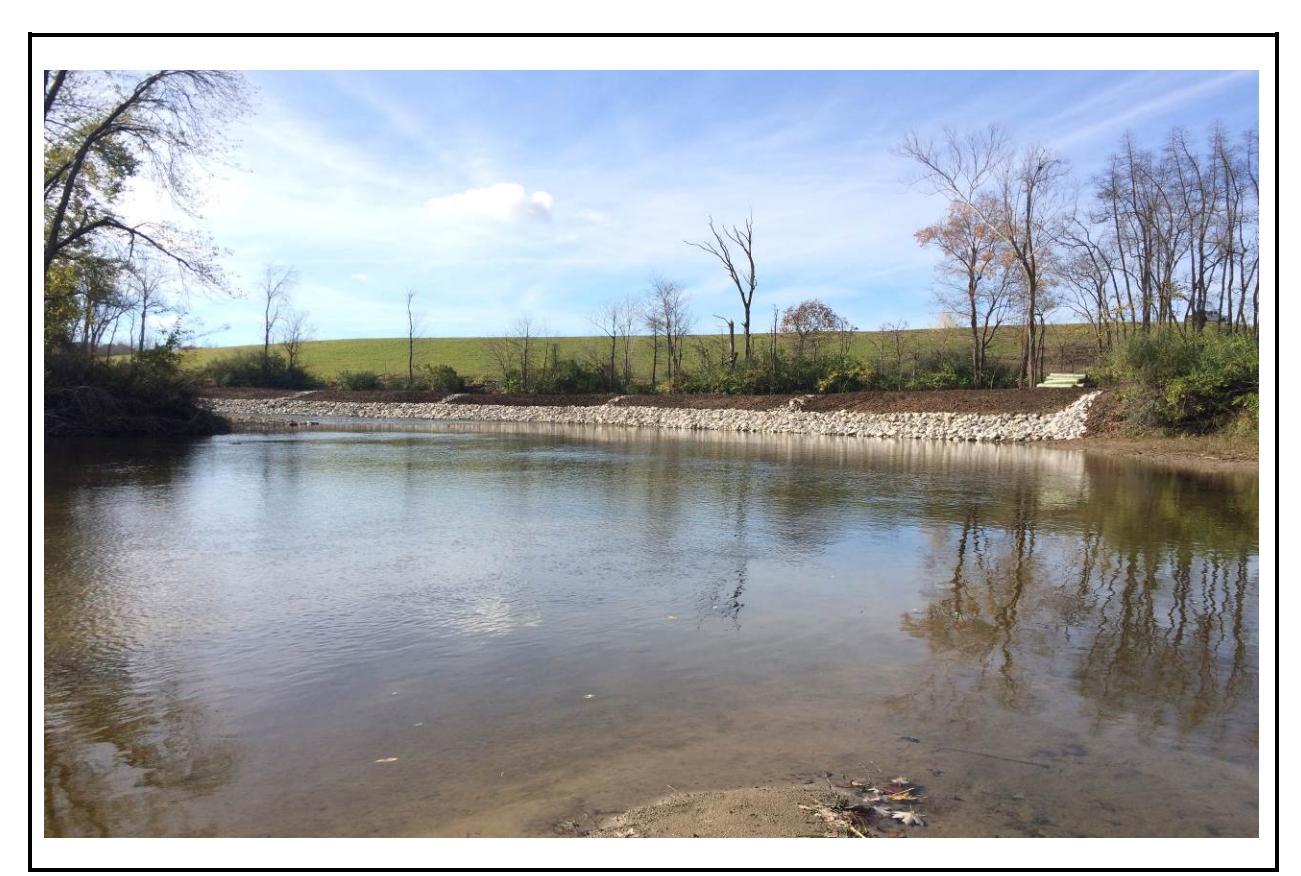
Photo 16. Completion of the keys
