April 6, 2016

RE: River Bank Stabilization Project along the Middle Fork Vermilion River; Vermilion Site;
10/5/2015 Joint Application #LRL-2008-1366 at Dynegy's coal ash storage facility

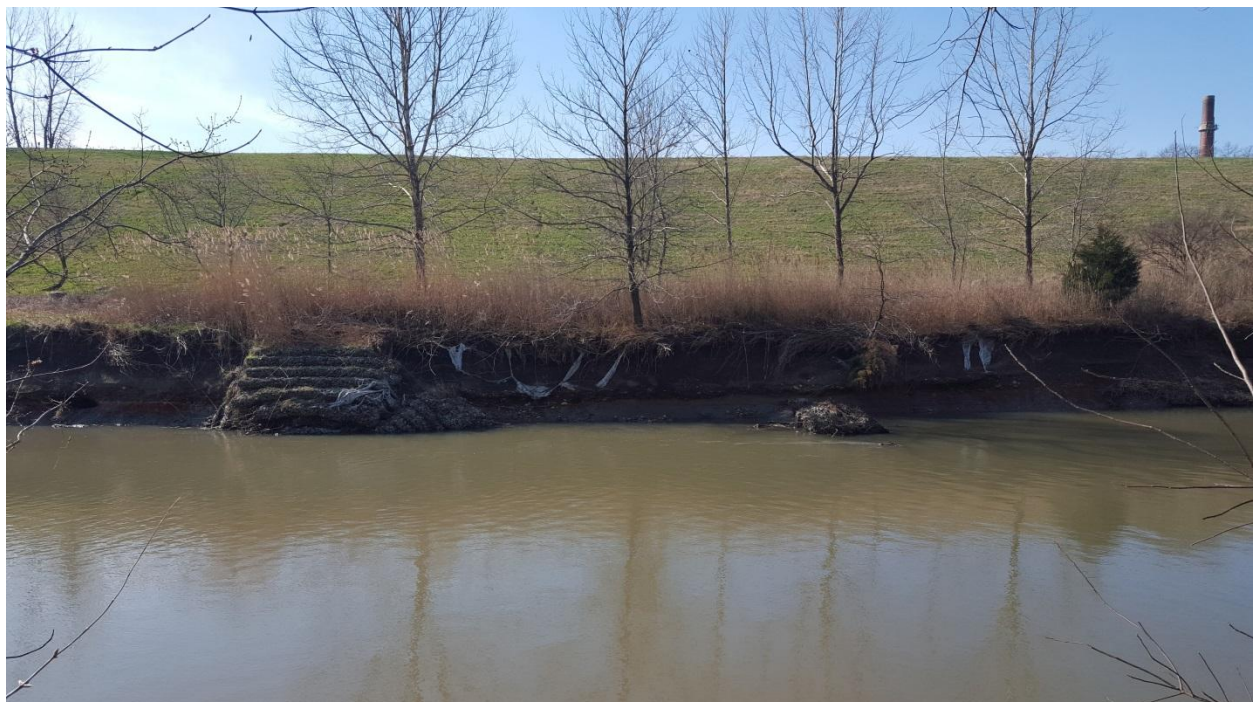
Illinois Power had originally installed gabions along the North and Old East ash ponds in 1980, yet failed to maintain them as they began to disintegrate the following decade. The present condition of the riverbank indicates that Dynegy's stewardship has also been minimal. The geofabric lining the banks is shredded. Wire cages have been corroded, releasing tons of rocks downstream and leaving the banks exposed to continuing erosion. The few surviving segments of gabions have been undercut, now slumping into the river. Meanwhile, the banks upstream and downstream of the remaining gabions are experiencing increased erosion.

The gabions in question (some pictured below) remain in disrepair – shredded, slumping into the river, and in many places completely absent.

Given Dynegy's record of neglect of the old gabions, what action can agencies take to assure the public that Dynegy will monitor and maintain any new bank armoring installed at a retired plant?

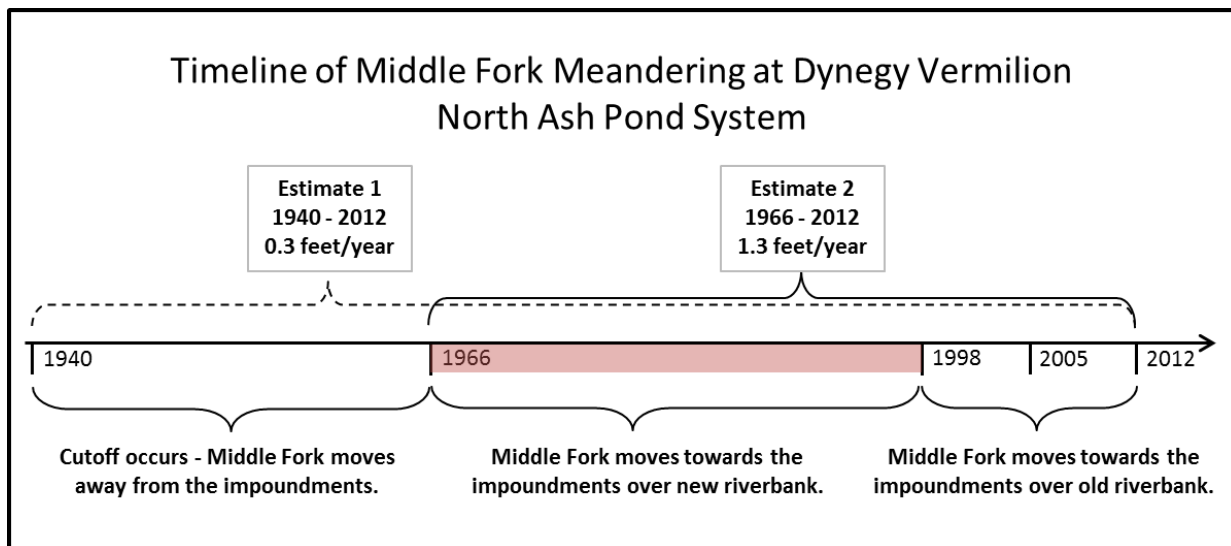
The Geotechnical Report's *0.3 feet per year* erosion rate is based on data spanning 1940-2012. This 72-year selection includes the river's migration away from the pond from 1940-1966, primarily due to the influence of a cutoff. Since 1966, however, the river has eroded exclusively toward the pond. The report estimates the erosion rate from 1966-2012 to be *1.3 feet per year*. The difference between these two estimates is explained in the figure below.

To justify choosing the *0.3 feet per year* (1940-2012) erosion rate in their time to failure calculations, the URS Corporation asserts that the erosion back towards the impoundments after 1966 was artificially fast, due to the effect of the cutoff. The argument is that the river would have been cutting back into a newer, less-compacted and less-vegetated riverbank which was deposited while it moved away from the impoundments. However, no analysis of whether or not the erosion in this period is in fact at a faster rate than other periods was documented.

This argument fails to justify their choice of the *0.3 feet per year* erosion rate because both erosion rate estimates would include this asserted period of high erosion, so it does not provide reason to select one or the other. This is the only justification for choosing the smaller erosion rate of *0.3 feet per year*, and it is unsupported and illogical.

Therefore, the *1.3 feet per year* erosion rate should have been selected because it represents erosion in a single direction and it doesn't include the effects of an unpredictable one-time cutoff. The report states that no additional cutoffs are expected. Even if there were additional cutoffs expected, the effect of those cutoffs on erosion is extremely unpredictable, and it could just as likely increase erosion at this site. Accordingly, using the *1.3 feet per year* erosion rate estimate, the time to failure in the analysis would decrease from 83 years to about 20 years. This alone is substantial cause for concern.

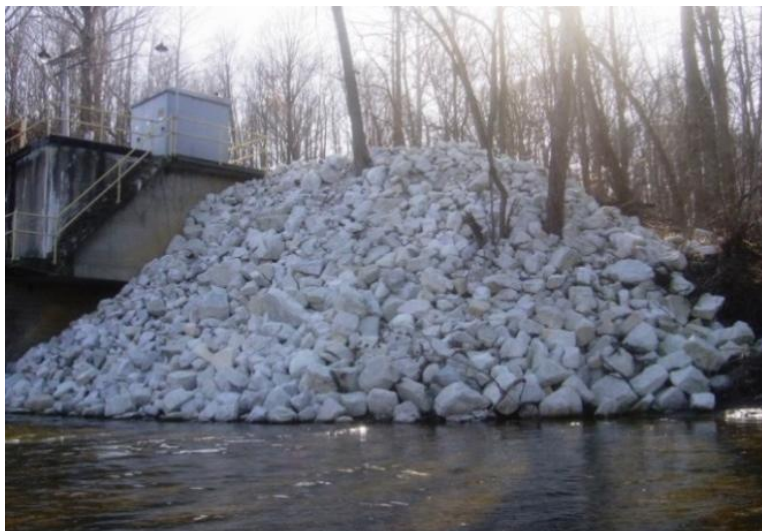
The photograph on the following pages shows the result of the approved stabilization work at the pump station, demonstrating extreme degradation to the river's scenic value.

Nevertheless, the river's natural beauty has marred by this massive pile of bright white stone. Any management decisions must ensure that future actions better protect the river's scenic beauty.
