# Evaluation of Public Safety at Run-of-River Dams

### 4.7.4 Sears Dam

The following section includes a description of the existing conditions of and proposed structural options for Sears Dam.

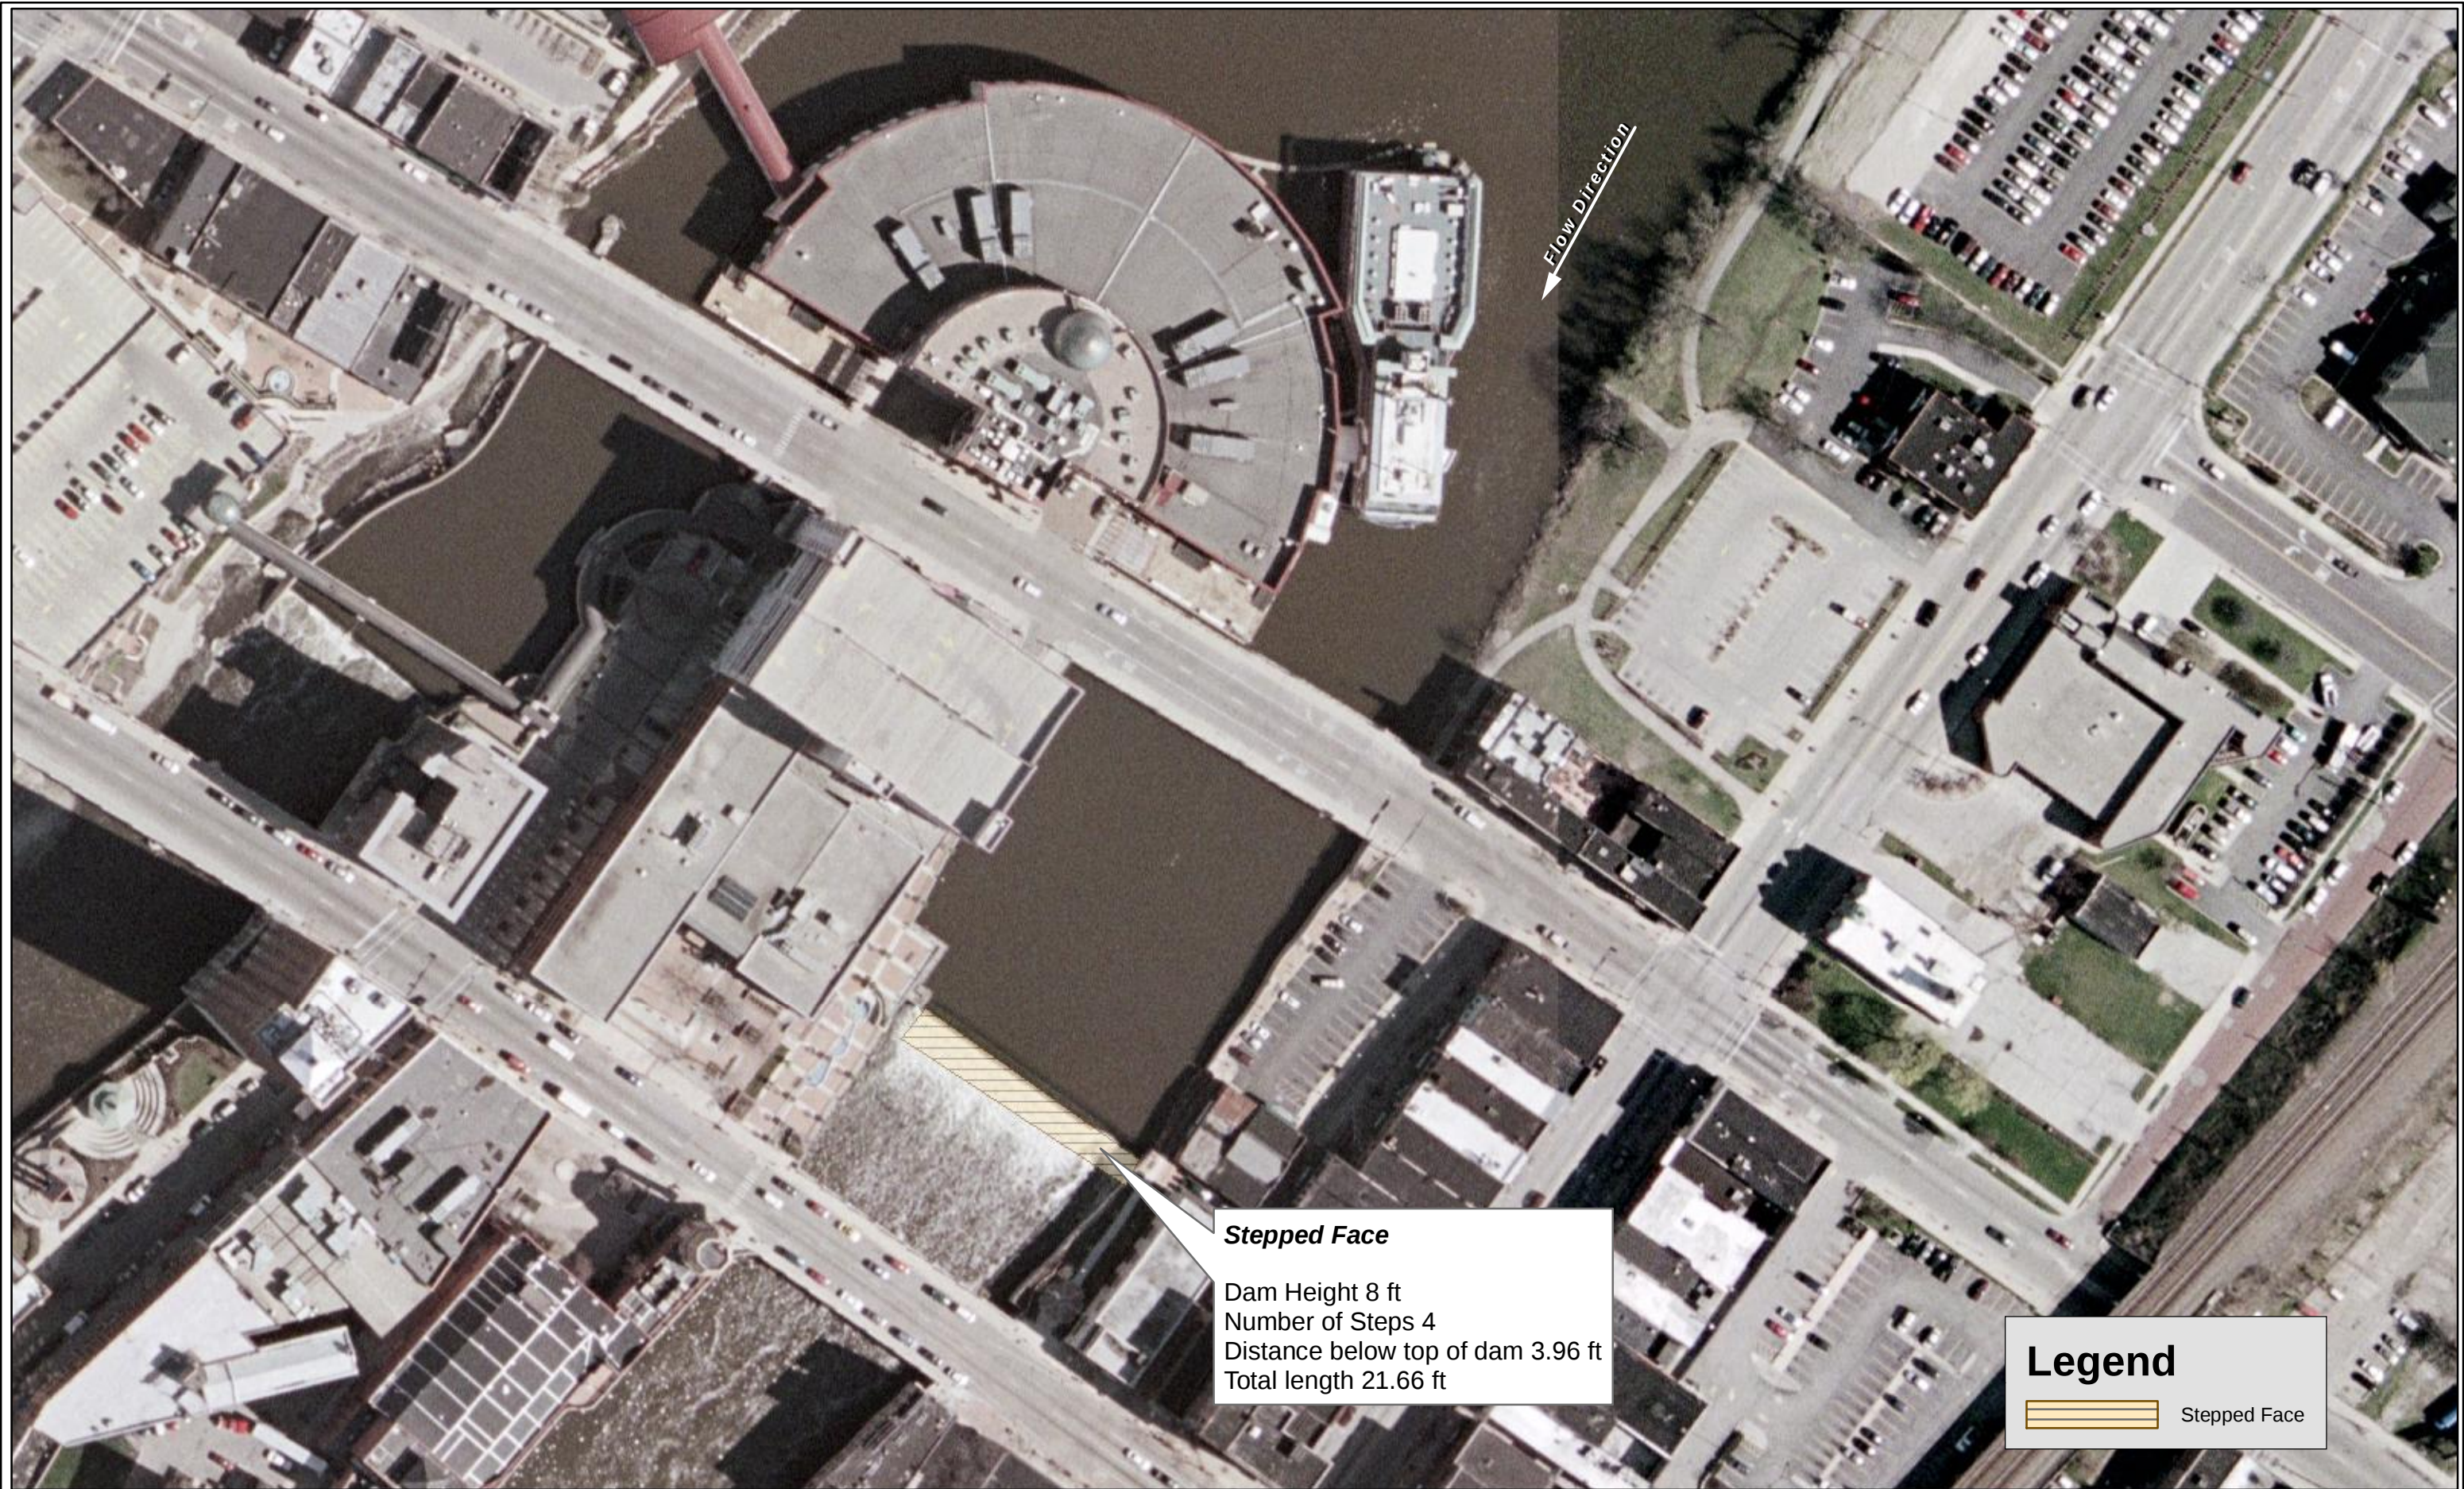
**DAM FACE  
MODIFICATION**

The costs for each option vary due to the type of material used, required access to the site, and other considerations that are discussed in the detailed cost section. The opinions of cost for the temporary rock fill and dam face modification are \$490,000 and \$1,560,000, respectively. The opinion of cost of dam removal is \$2,900,000.

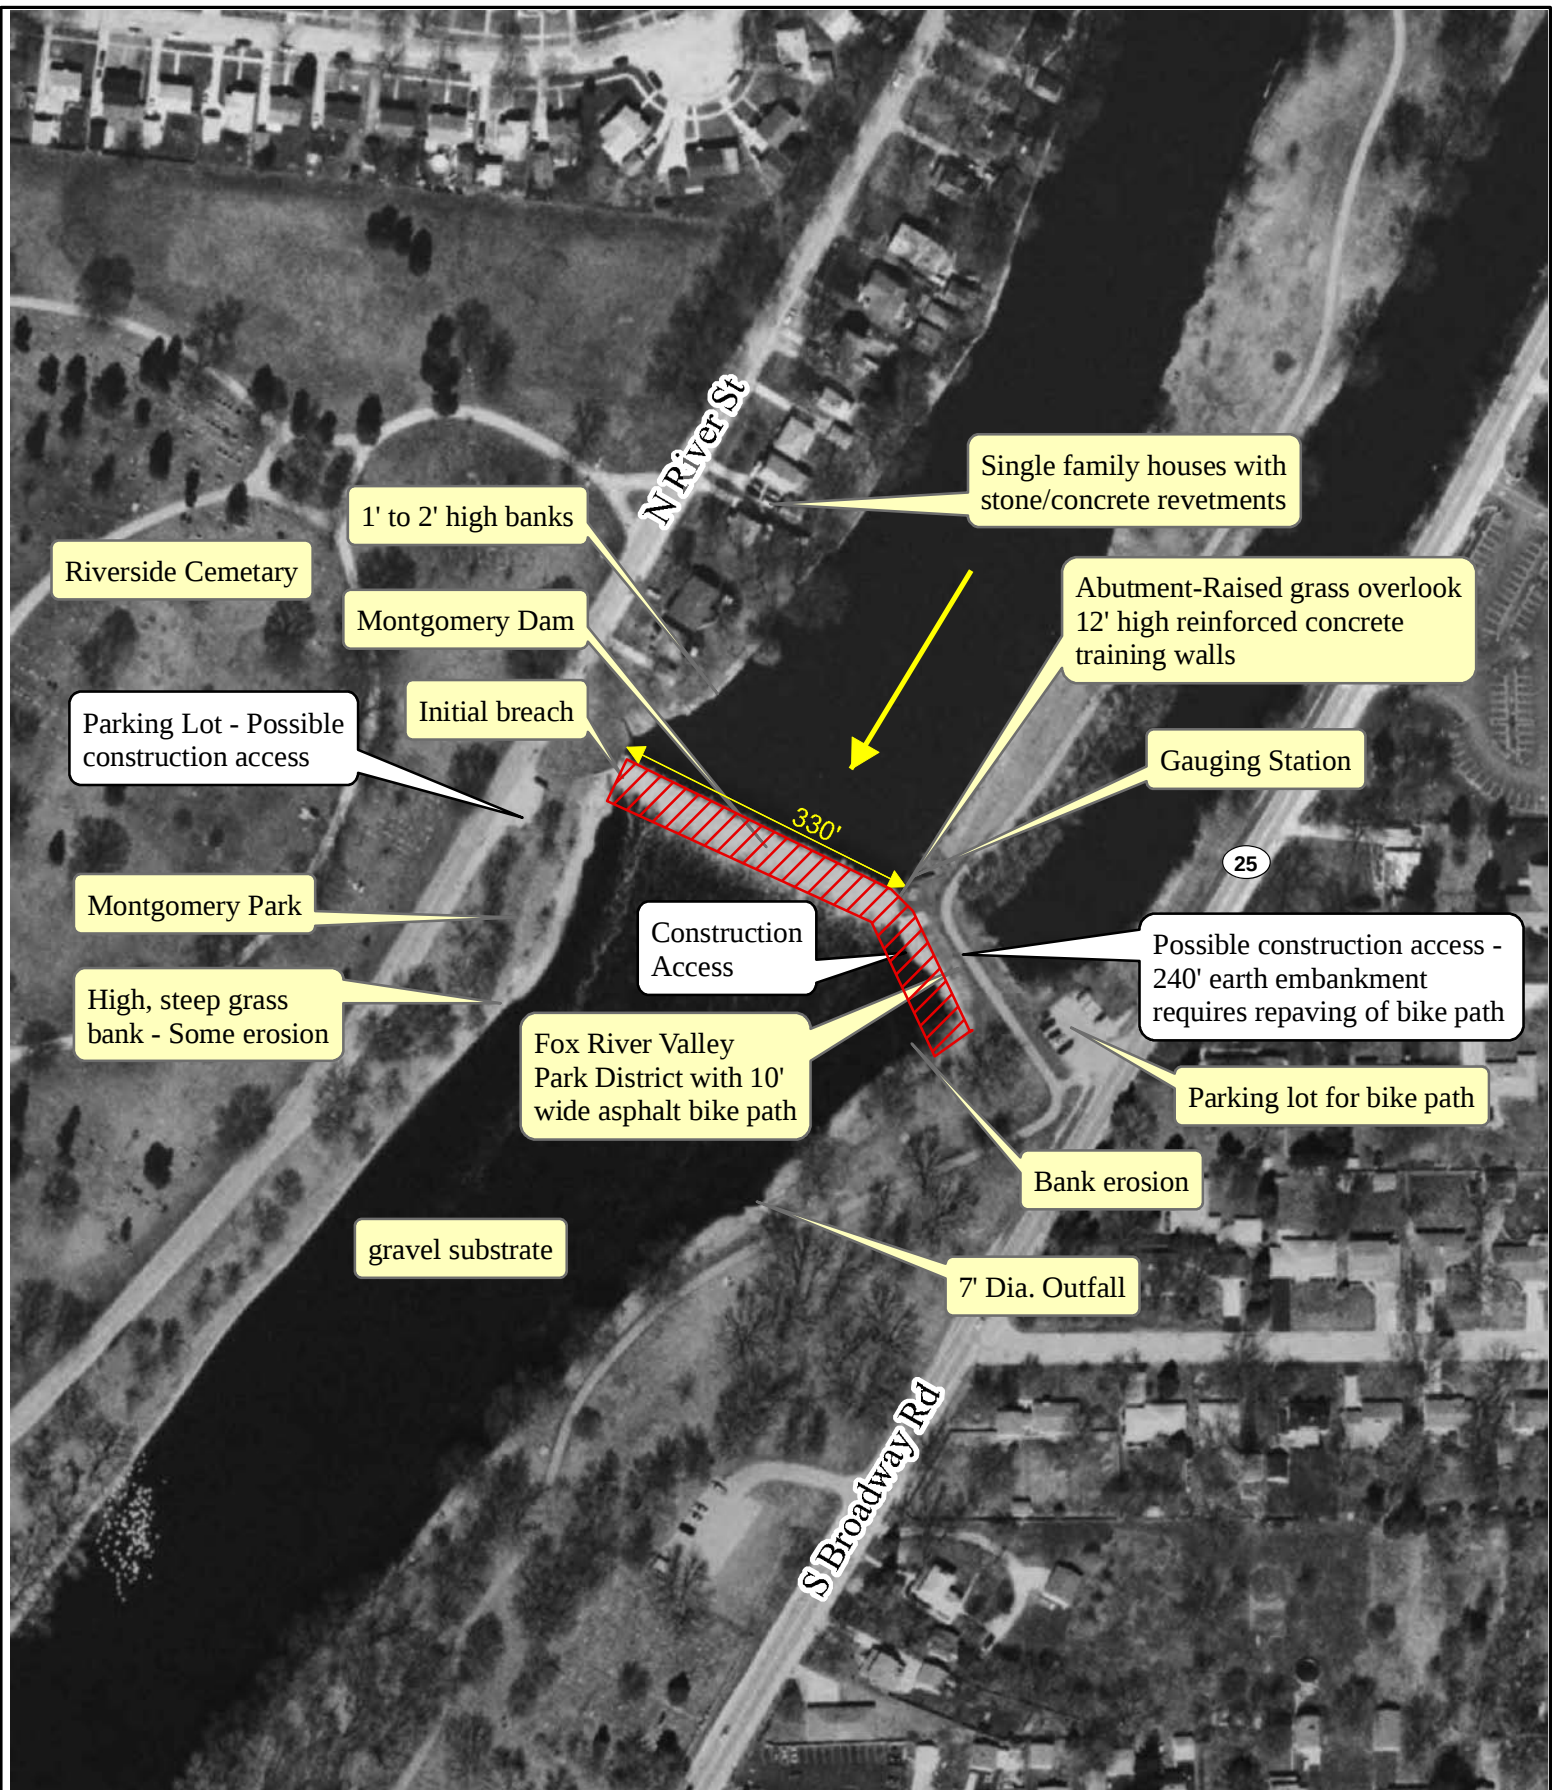
There are no special issues at this dam. As with any dam removal, evaluation of pre- and post-condition velocities, water levels, and sediment management would be necessary.

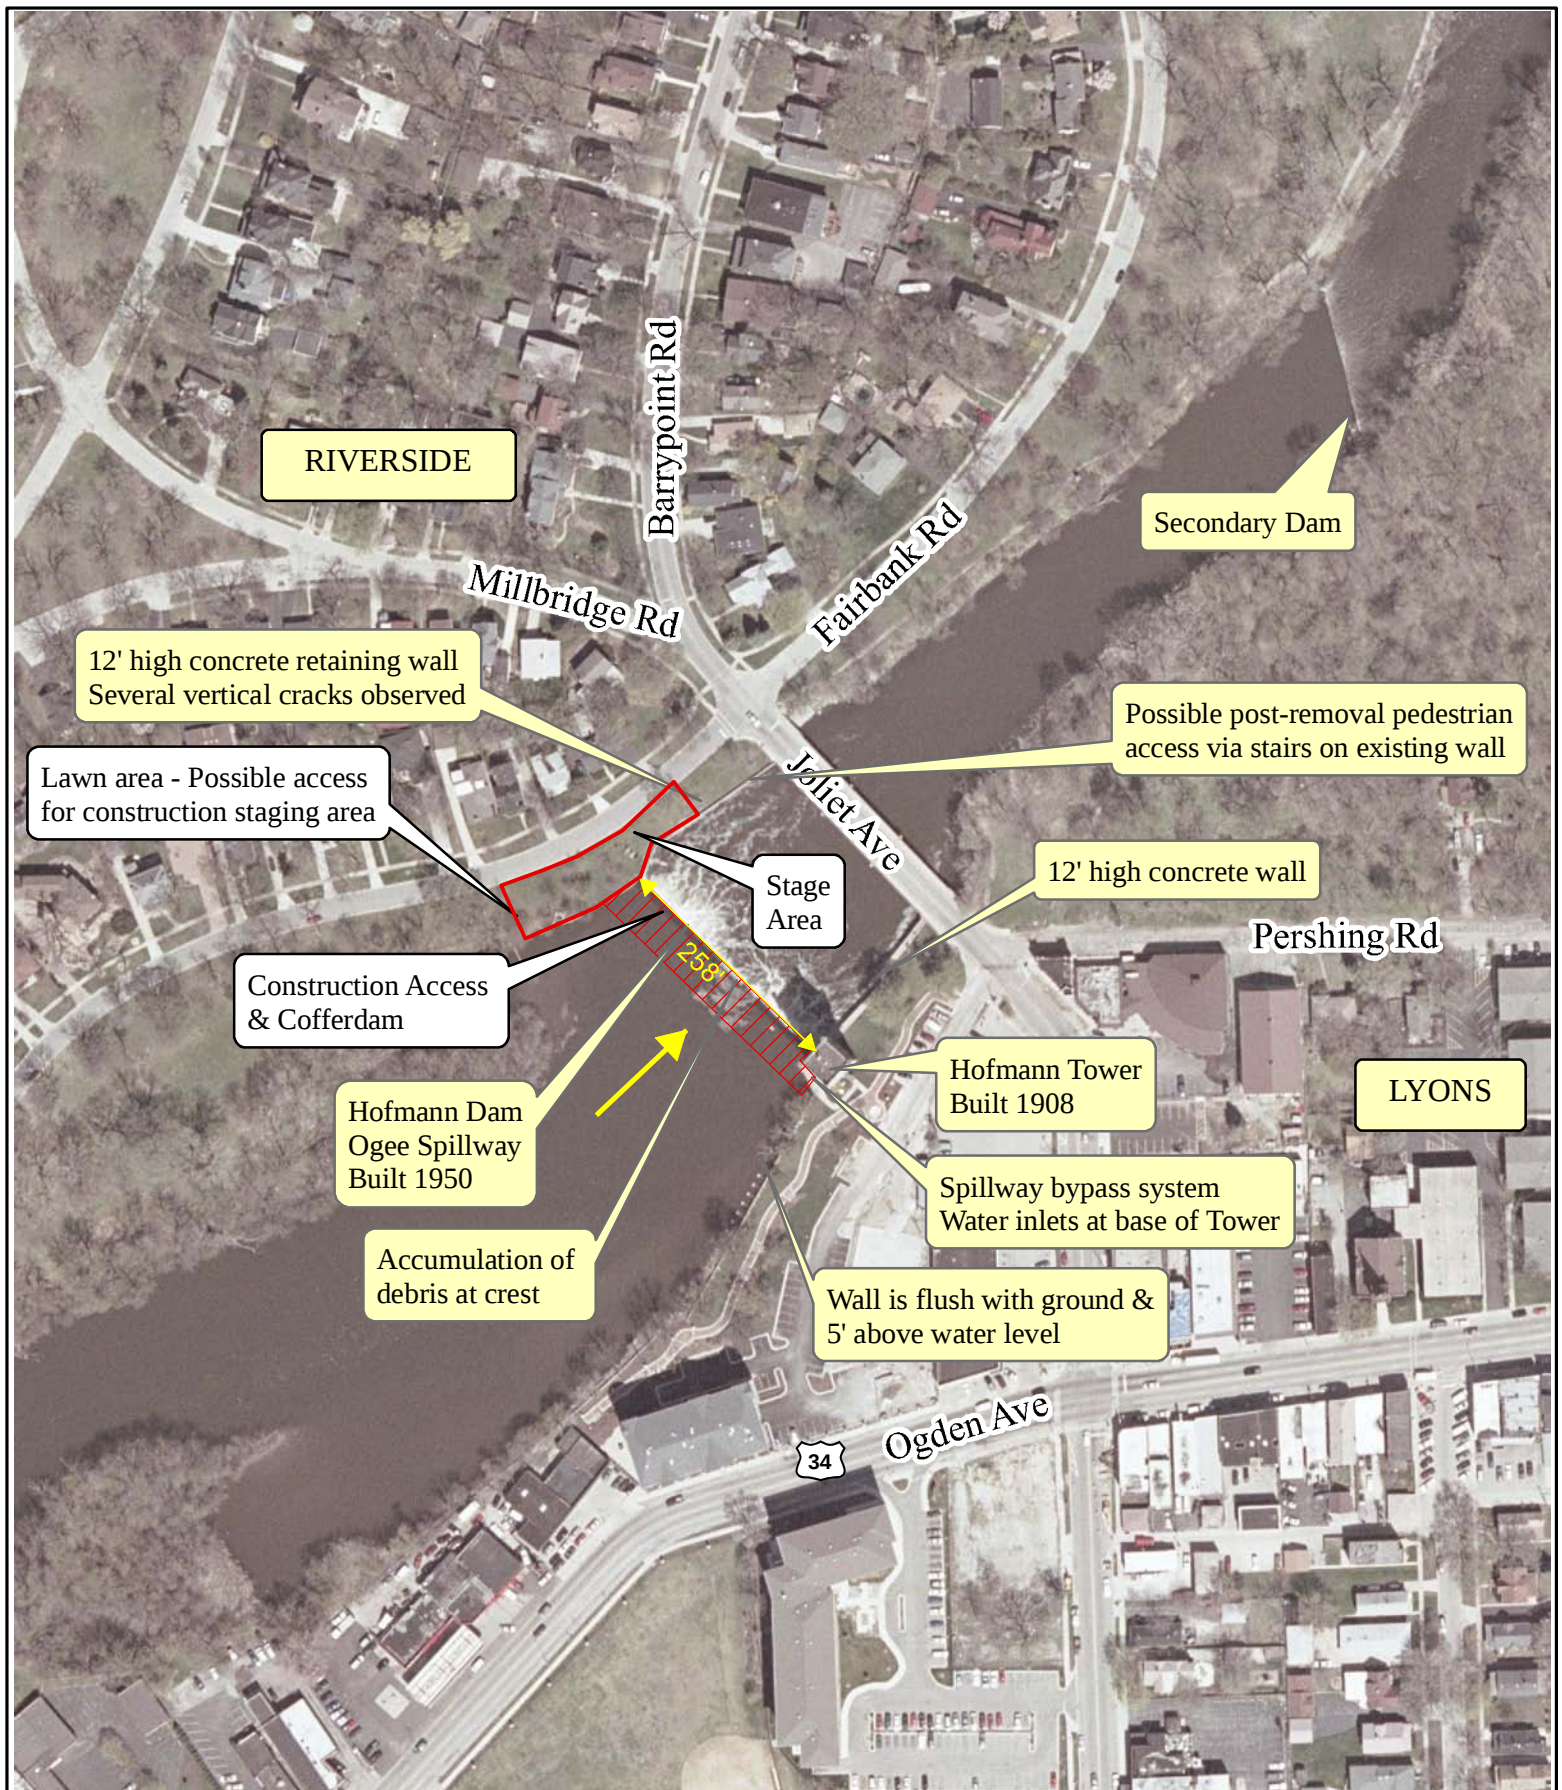
**SHEET:**  
**Figure 4.9.1.2.2**

- o Pedestrian access to the Des Plaines River from the Village of Lyons side could be accomplished by building upon the existing concrete retaining wall structure extending out along the top of the existing dam to create a walkway and accessway down to the newly created stream bank. Grading in this area can be designed to provide a gradual transition from the higher elevation of the upland to the new edge of river.
- o Pedestrian access from the Village of Riverside bank could be accomplished through a new connection to Swan Pond Park or by constructing direct access via stairways leading down from the existing concrete wall.
- o As with any dam removal, design will need to consider sediment management, erosion, and post-construction water levels.

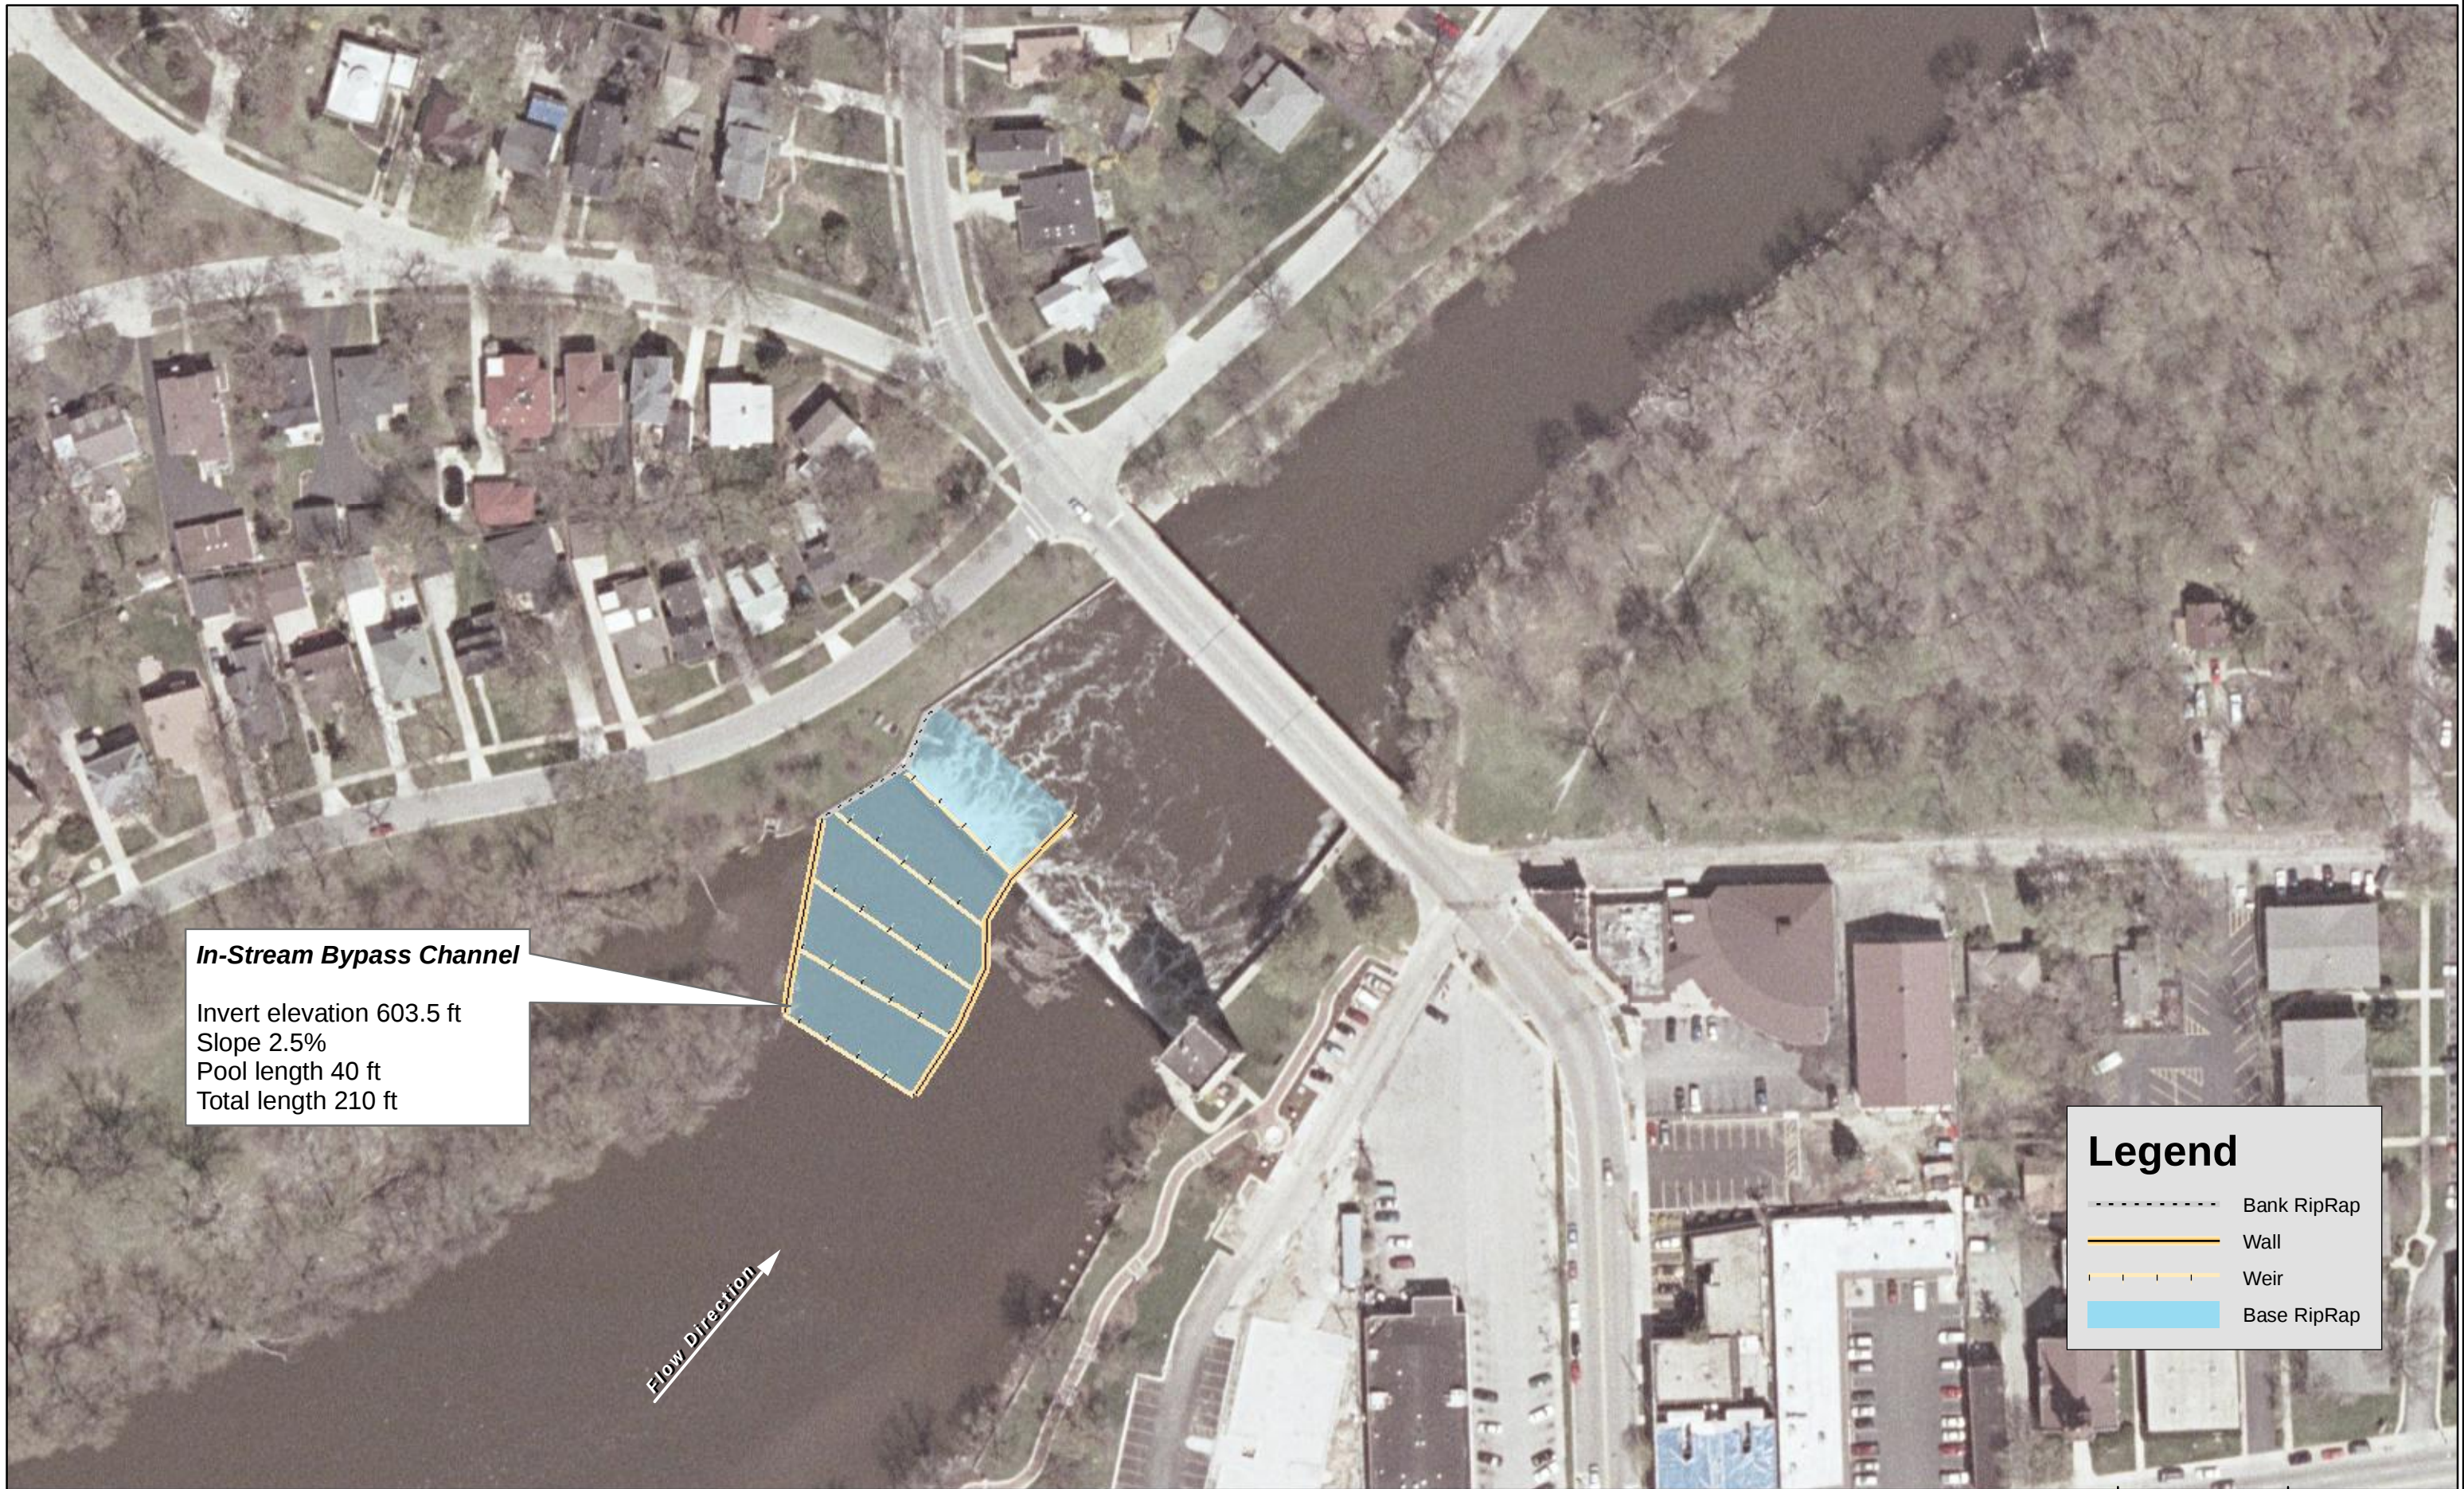
***In-Stream Bypass Channel***  
Invert elevation 603.5 ft  
Slope 2.5%  
Pool length 40 ft  
Total length 210 ft

An in-stream bypass channel concept was developed for this reach (See Figure 4.9.1.2.5). A 100-ft wide bypass, with a 2.5% slope could be most easily constructed on the left bank. This would involve notching approximately 100 ft of the dam. The bypass should be constructed mostly upstream of the dam, due to the proximity of the downstream bridge. This bypass would prevent overtopping of the dam up to the 5-year FIS flow as well as allow for boat passage. Detailed survey would be required to further determine the feasibility of this solution as well as examine downstream flooding on the left bank.

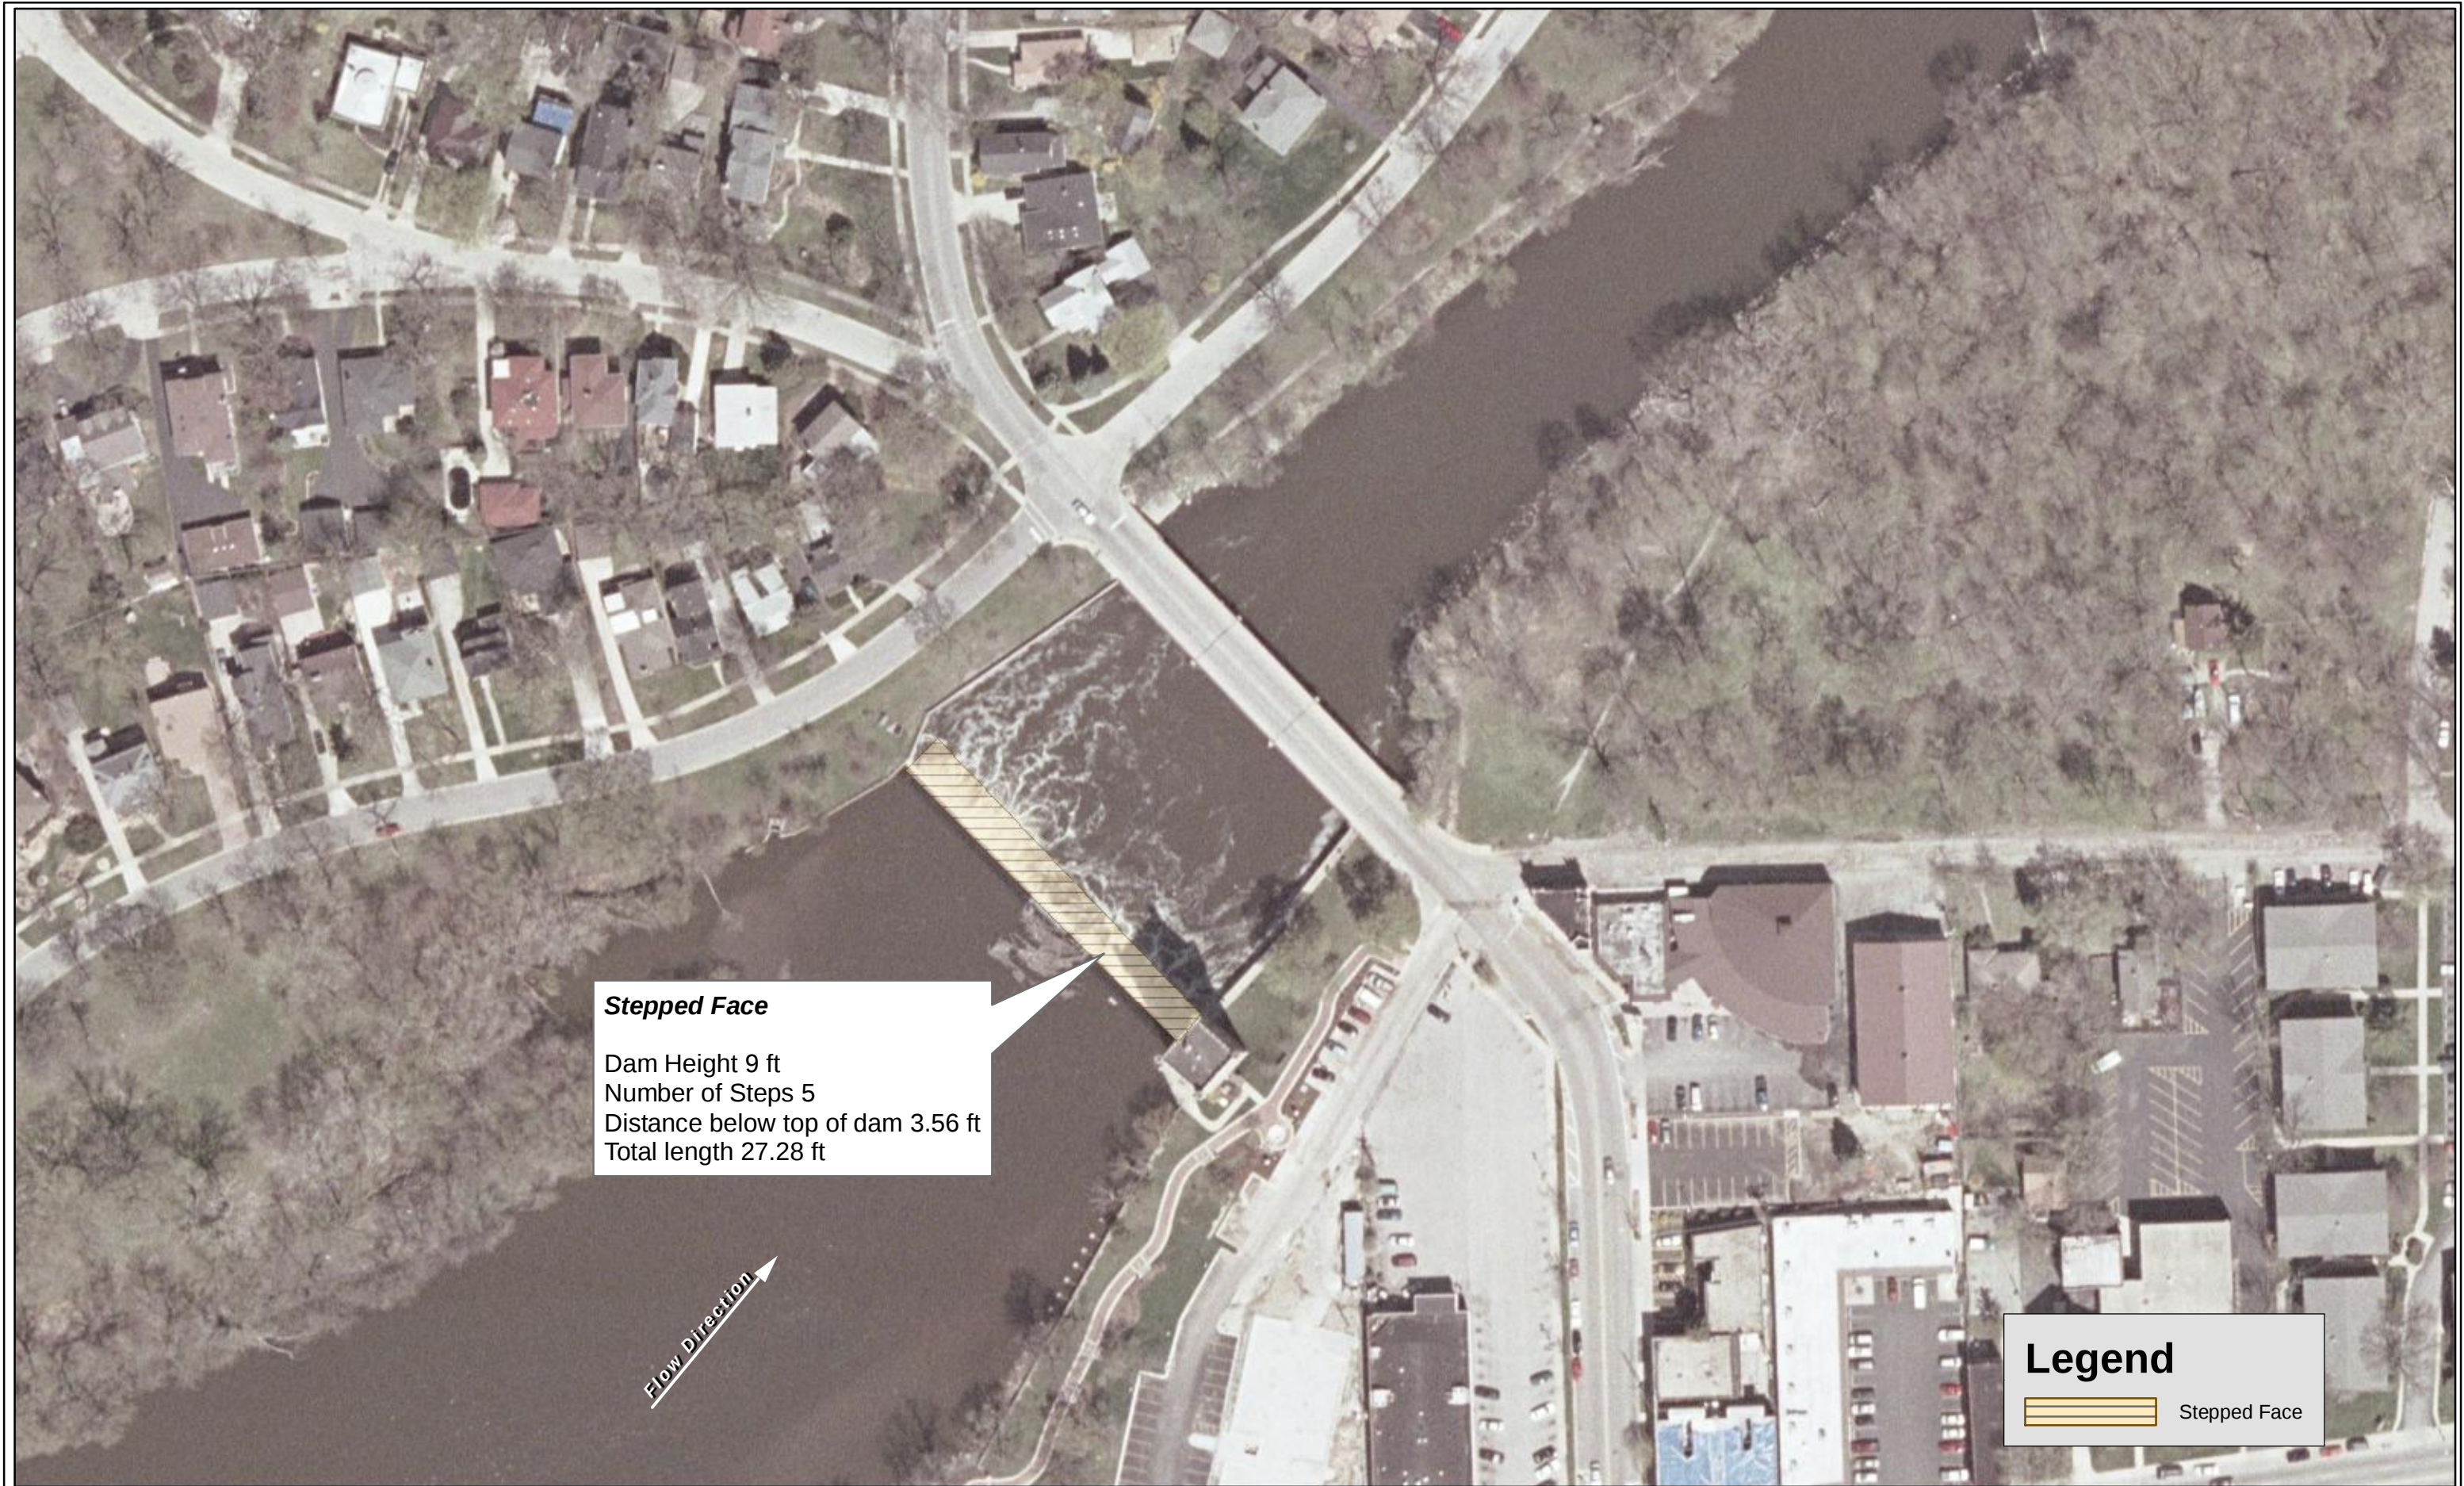
Figure 4.9.1.2.6  
Hofmann

A dam face modification concept developed for this reach (See Figure 4.9.1.2.6). A stepped face structure with 9 steps is proposed for this dam. The stepped face would extend approximately 28 ft downstream of the dam face. Hydraulic studies and physical modeling of the proposed structure would be required to determine a final design and the effectiveness of the stepped face.

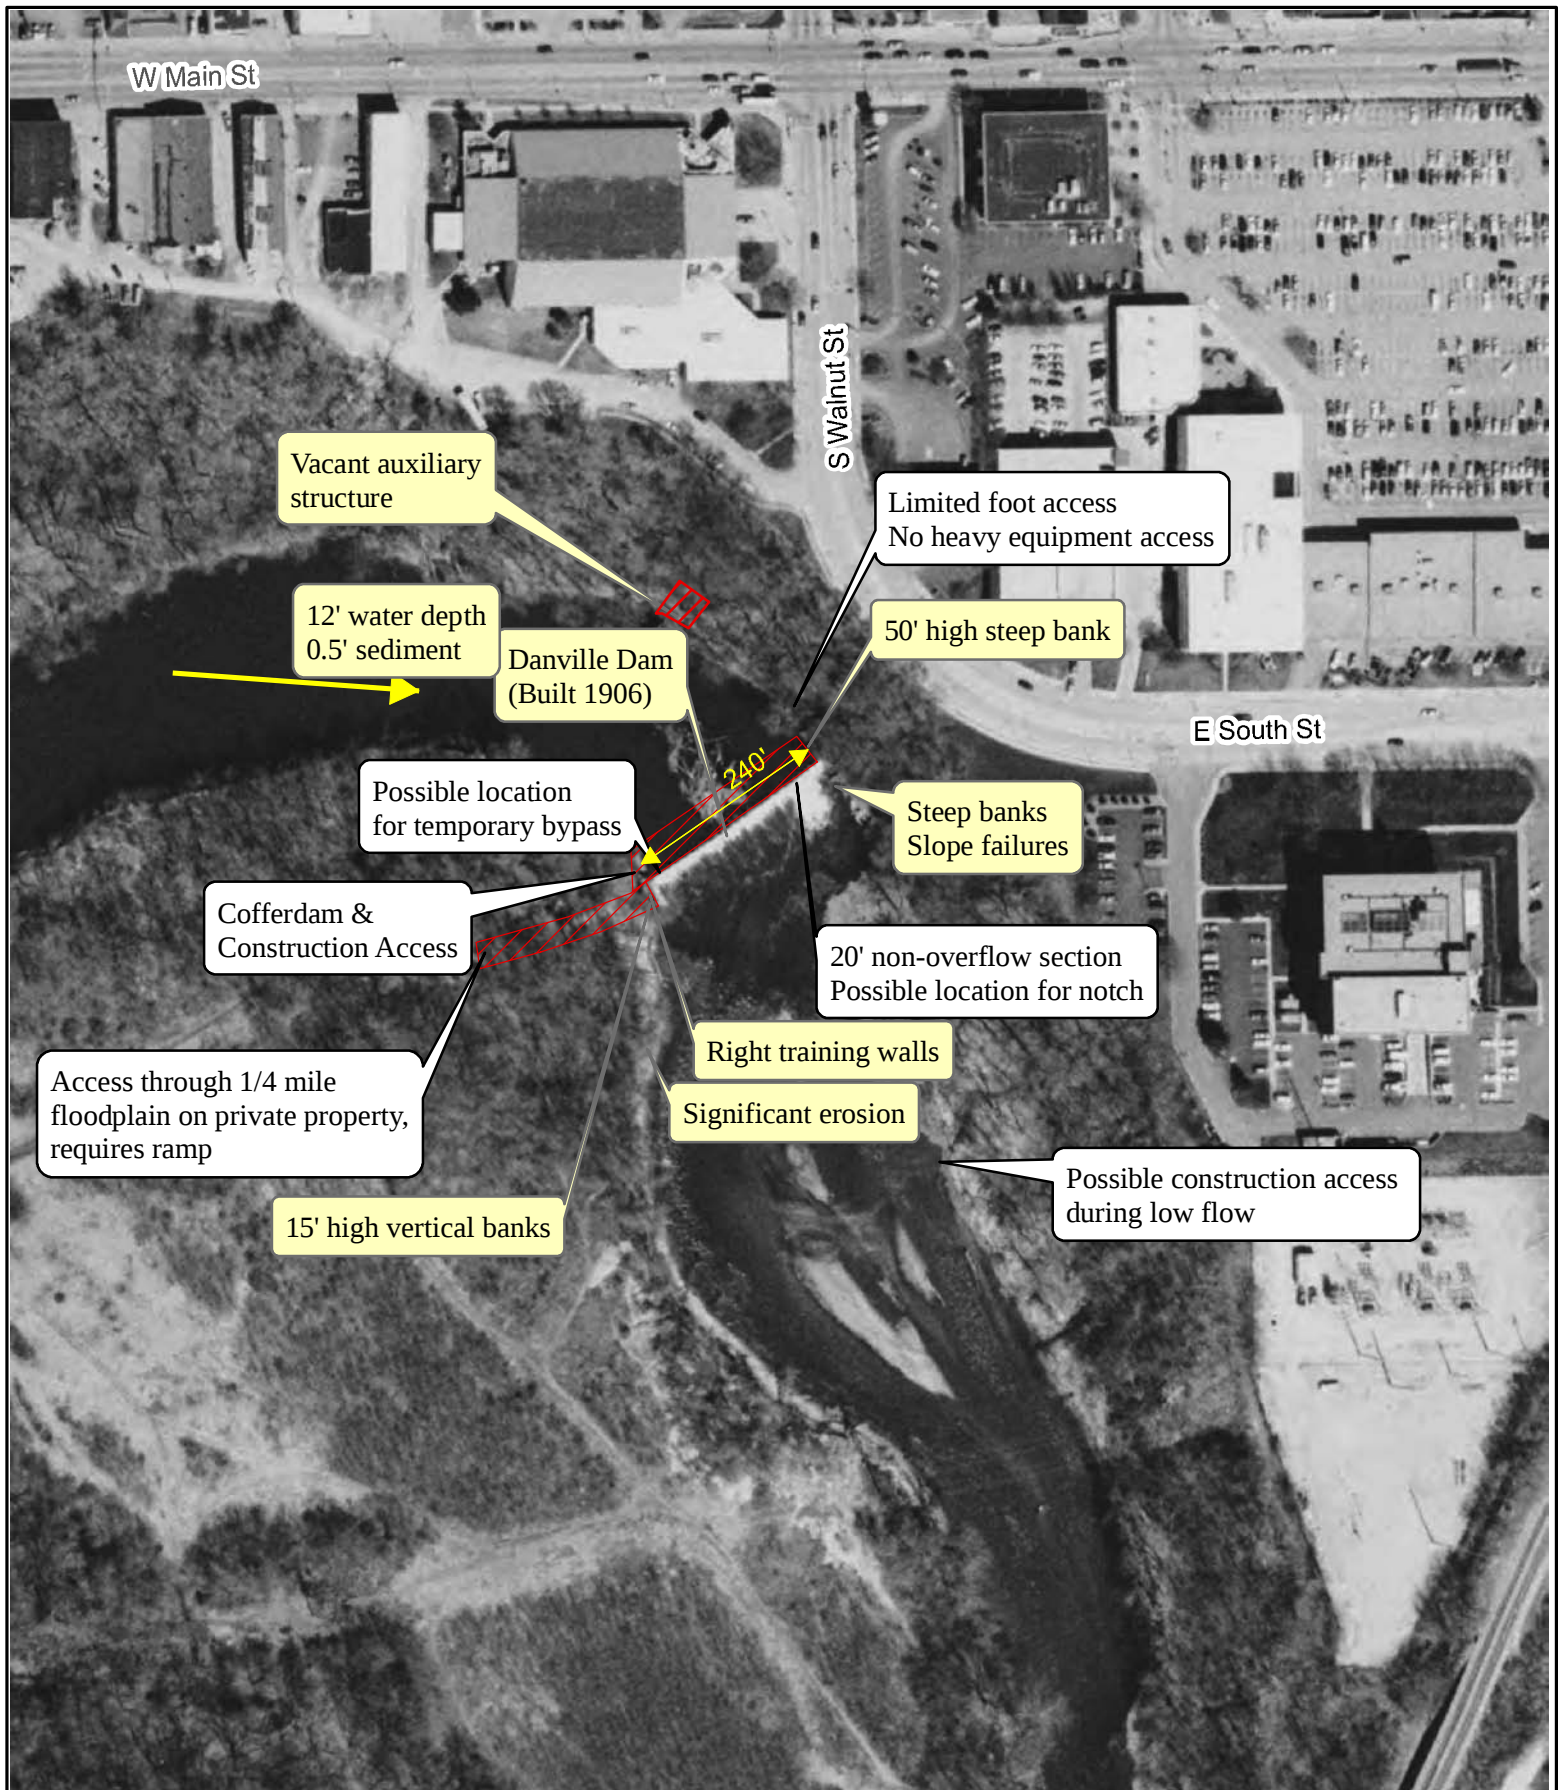
SHEET:  
**Figure  
4.10.1.2.2**

- o The left and right banks downstream of the dam are both erosion-prone and could collapse if drawdown waters cause asymmetric flow or eddies. The upstream banks may also be prone to severe erosion, unless stabilized, after drawdown.
- o The Route 150 bridge over the main stem and 136 bridge over the north fork upstream of the dam both have piers in the water that could be prone to scour and need to be checked, along with the Ellsworth Park area channel, dams, and outfalls.
- o Secondary structures, namely concrete piers, at the Danville Dam should be secured or removed. They are an unattractive nuisance.
