# Evaluation of Public Safety at Run-of-River Dams

### 4.7.4 Sears Dam

The following section includes a description of the existing conditions of and proposed structural options for Sears Dam.

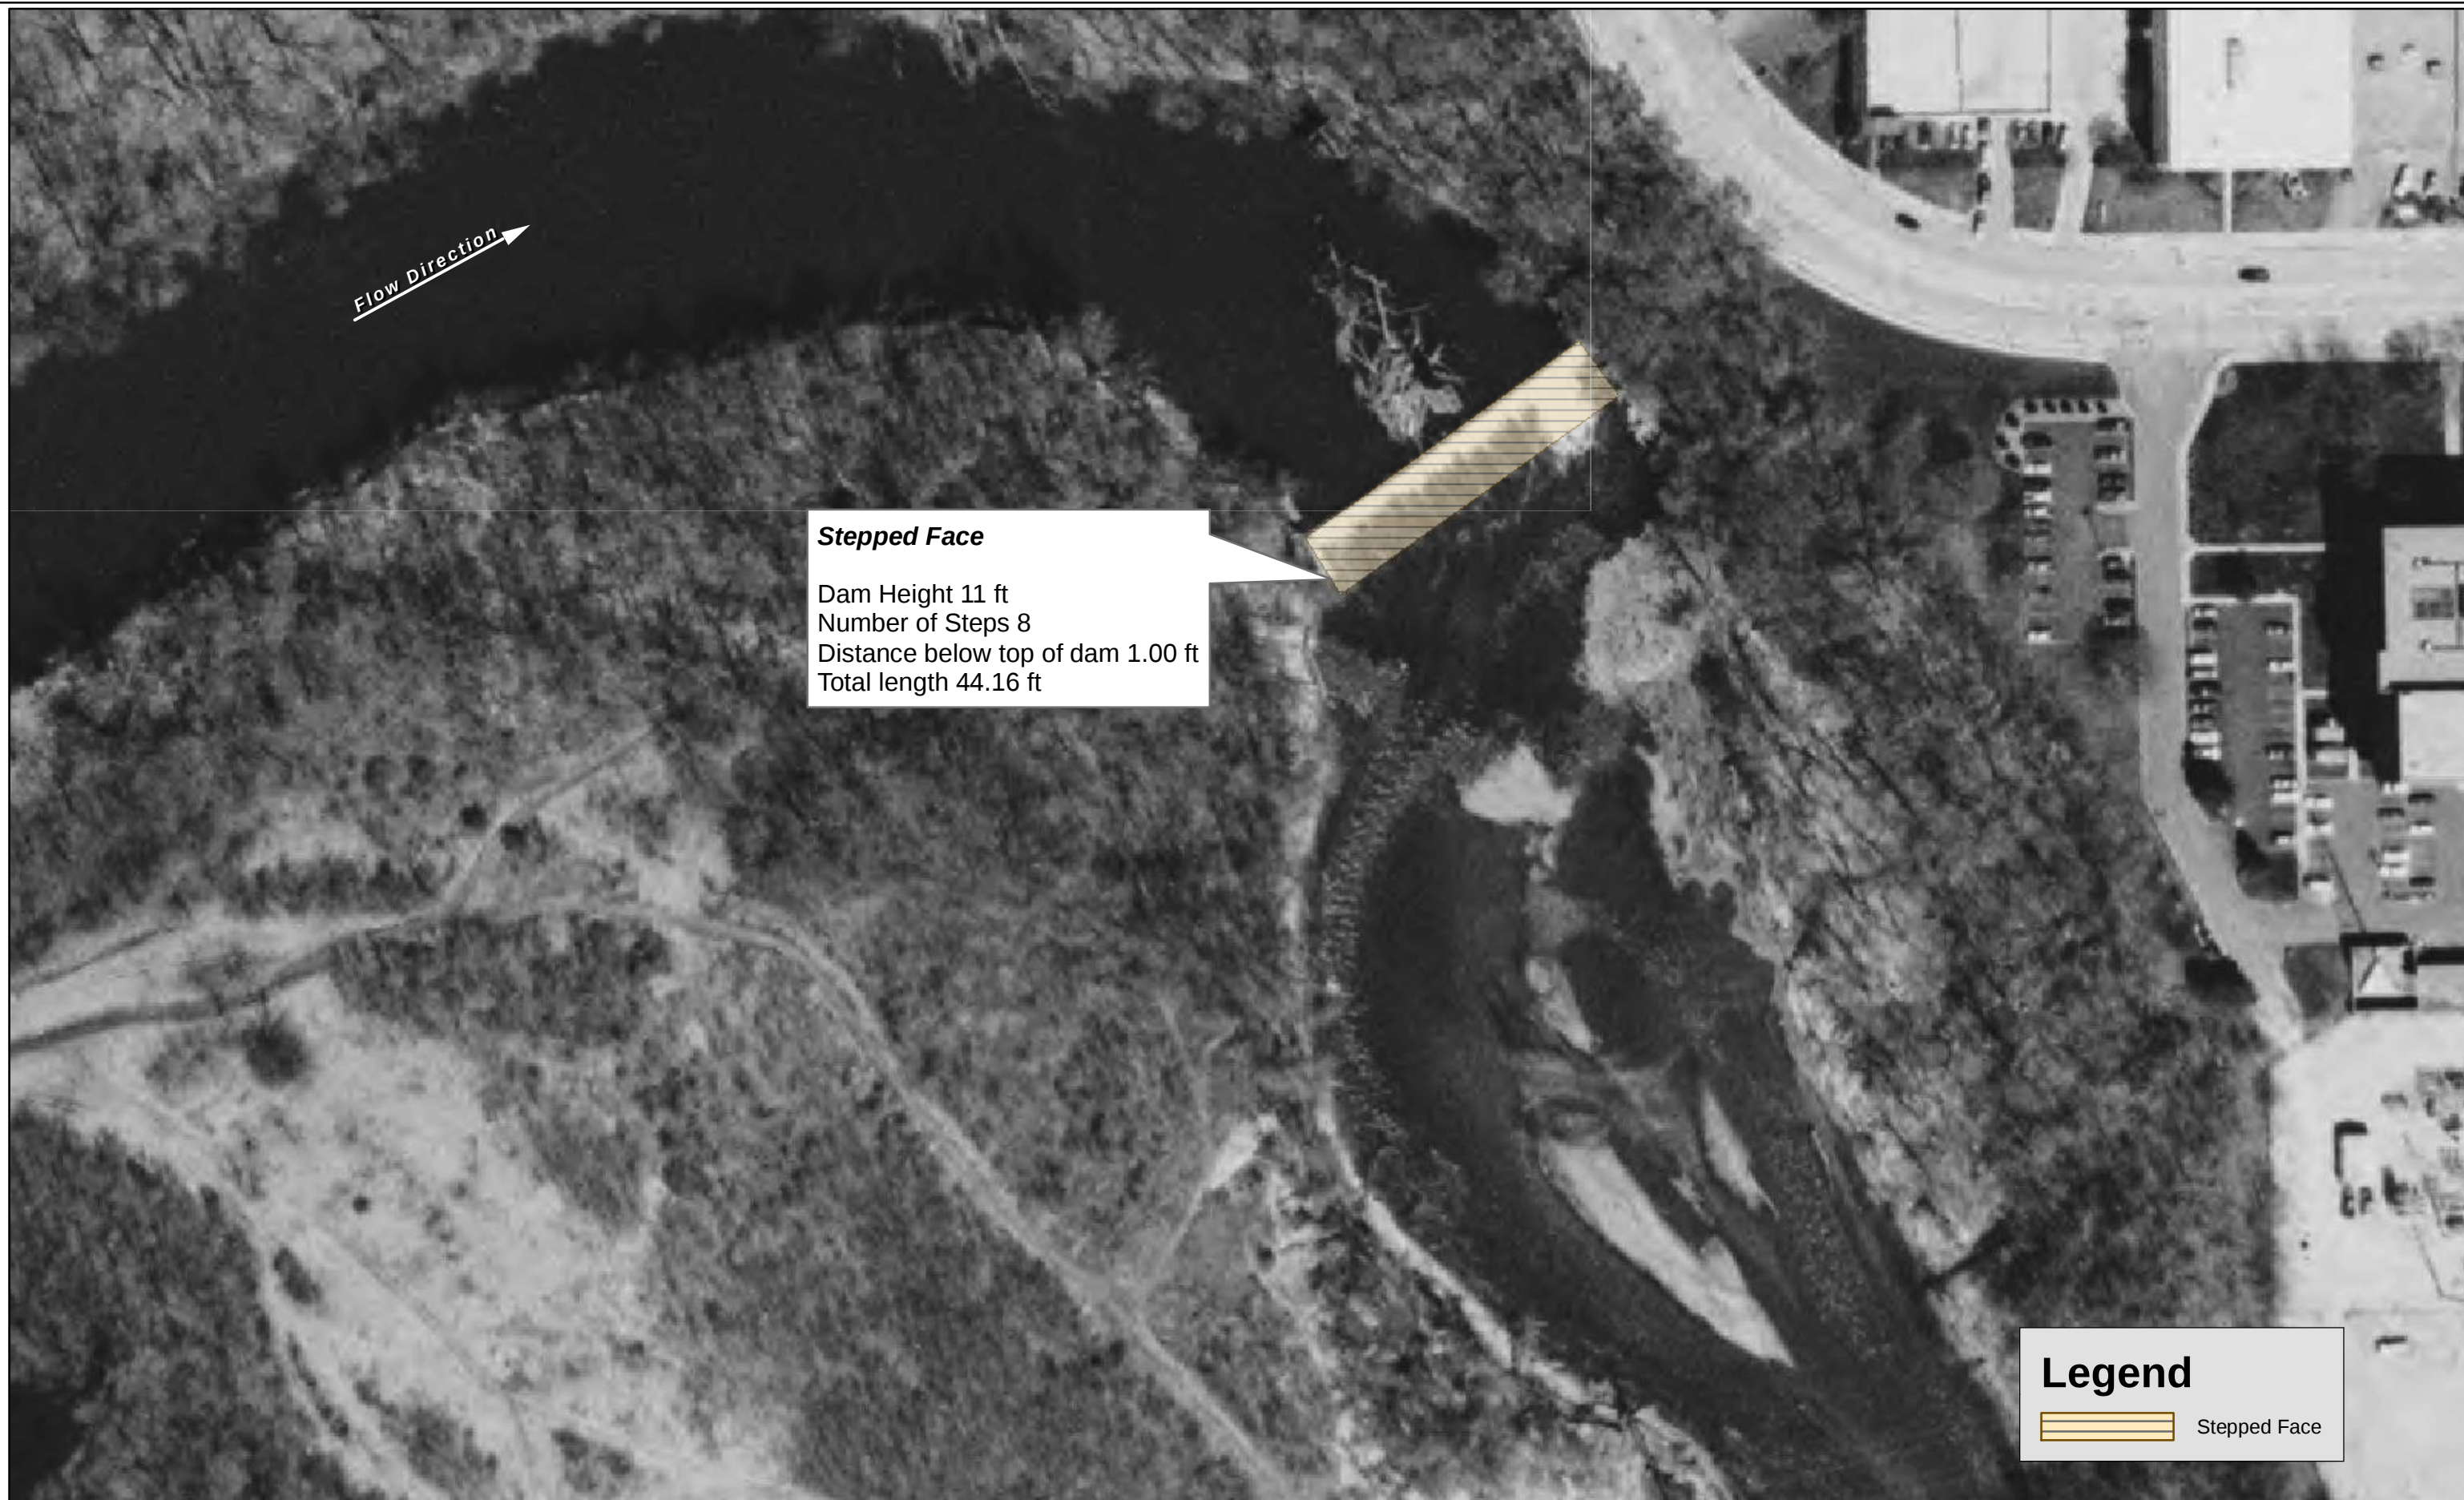
Figure 4.10.1.2.6

A dam face modification concept developed for this reach (See Figure 4.10.1.2.6). A stepped face structure with 11 steps is proposed for this dam. These steps would extend to approximately 45 ft downstream of the dam crest and would begin 1 ft below the dam crest. Hydraulic studies and physical modeling of the proposed structure would be required to determine a final design and the effectiveness of the stepped face.
