Middle Fork Vermilion River Stabilization of the Right Descending Bank at Approximate River Mile 36.2 Nationwide Permit #13; LRL-2008-1366-lcl <u>Project Completion Report</u>

Project Completion Report

DYNEGY MIDWEST GENERATION, LLC VERMILION SITE OAKWOOD, ILLINOIS

RE: Project Completion Report Dynegy Midwest Generation, LLC - Vermilion Site Oakwood, Illinois SCI No. 2009-3006.35

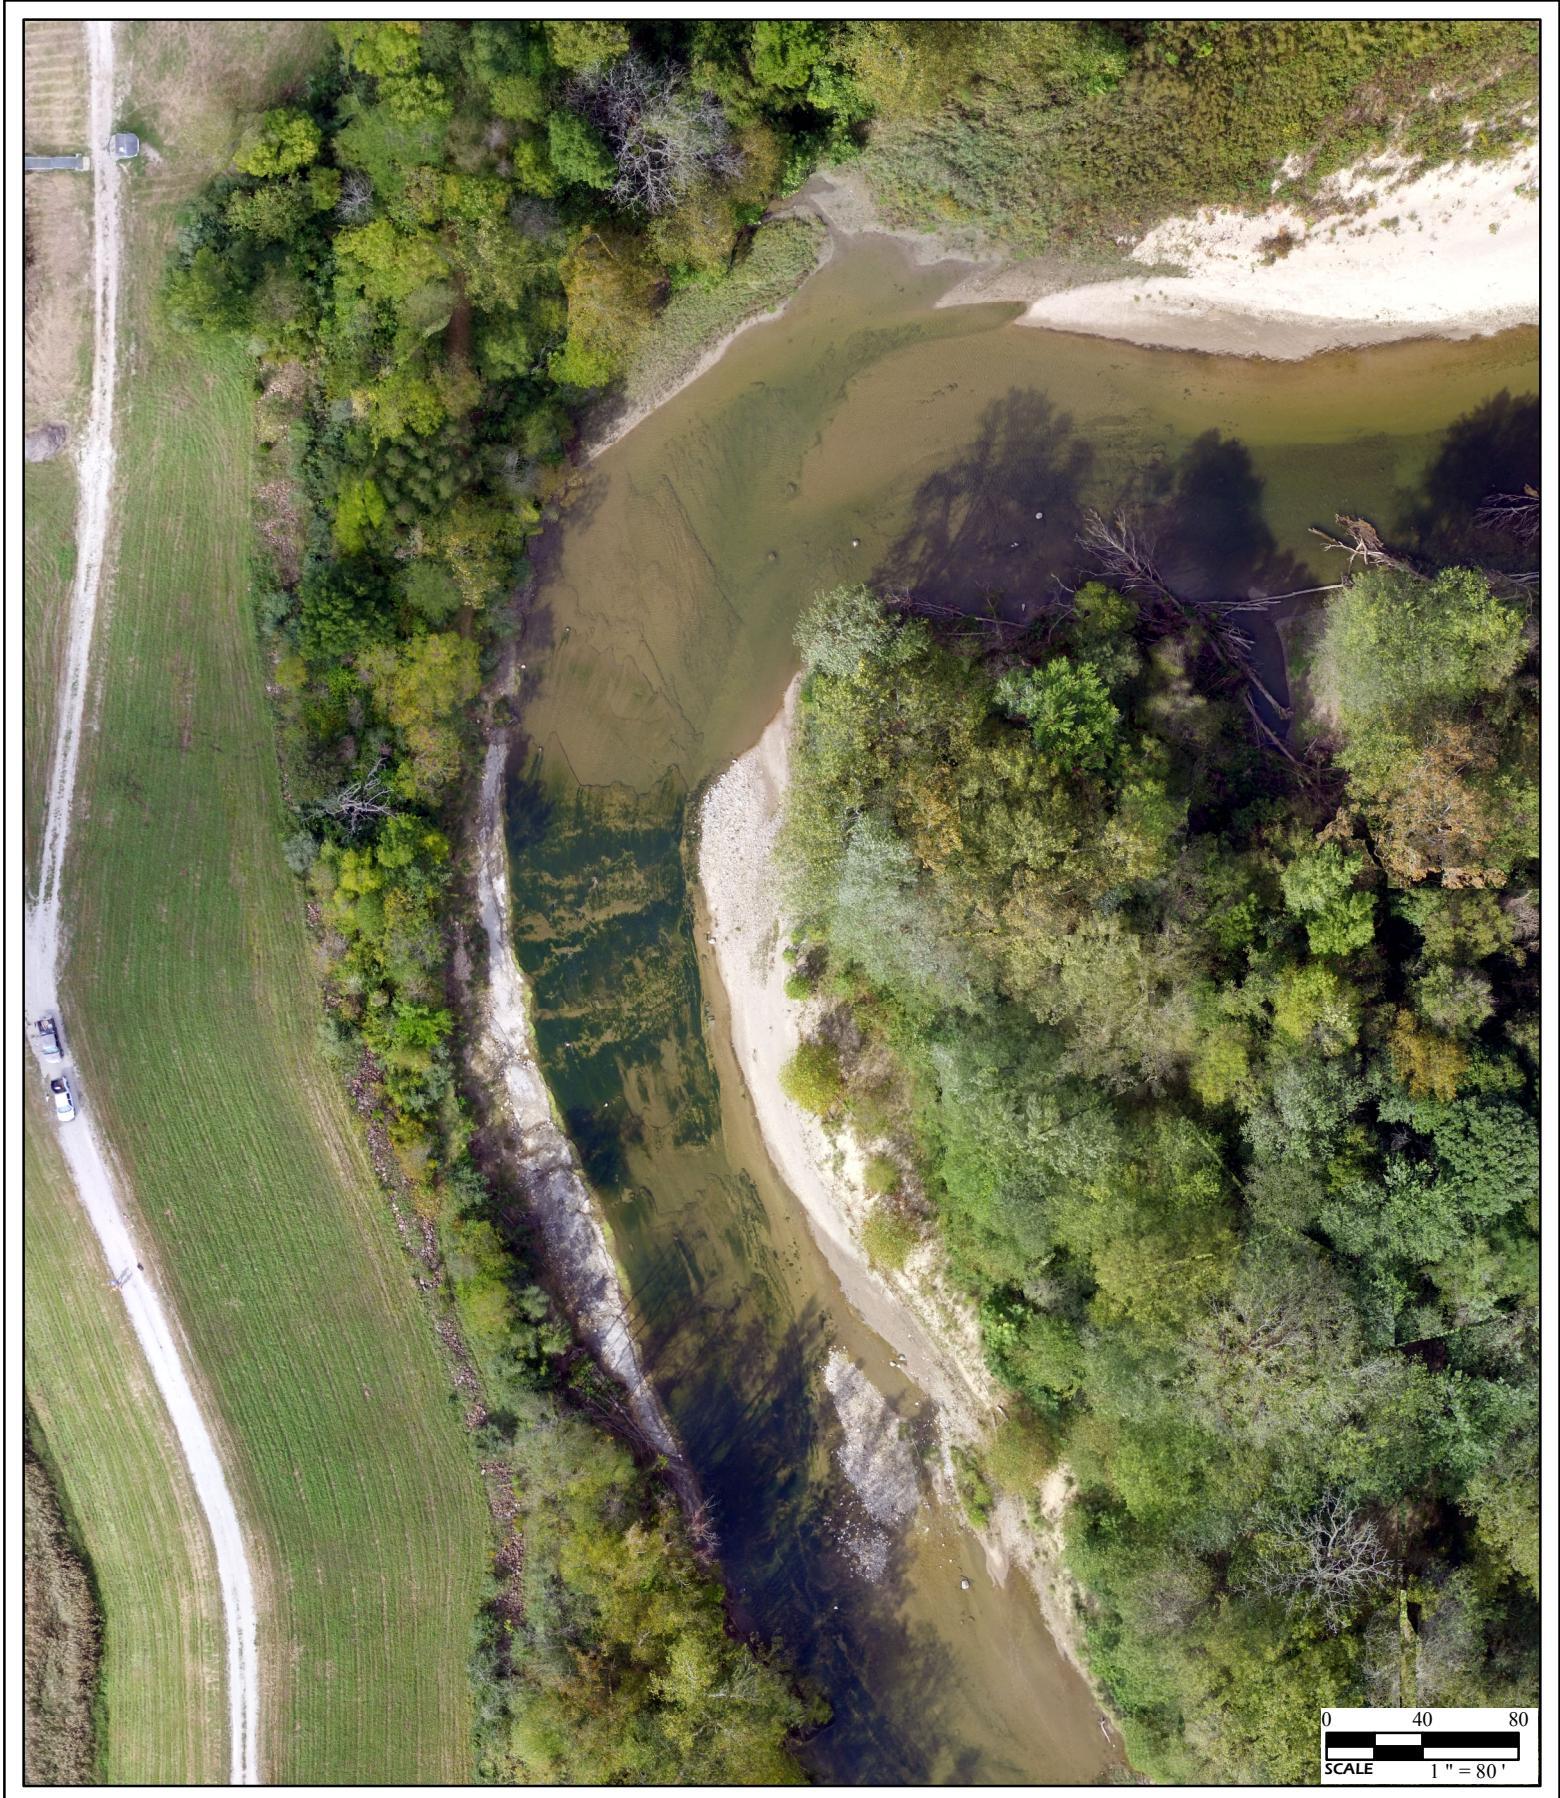
SI	DYNI	PI Egy Midw Vef Oakv	ROJECT NAME VEST GENERAT RMILION SITE VOOD, ILLINOI	ION, LLC – S	_GENERAL NOTES/LEGEND	W
		AERIAI	L PHOTOGRA	.PH		s s
_	DRAWN BY	RCV	DATE	JOB NUMBER	1	FIGURE
	CHECKED BY	MKW	02/2017	2009-3006.35	AERIAL PHOTOGRAPH OBTAINED FROM SCI UAV OPERATIONS, 10/05/2016.	2A

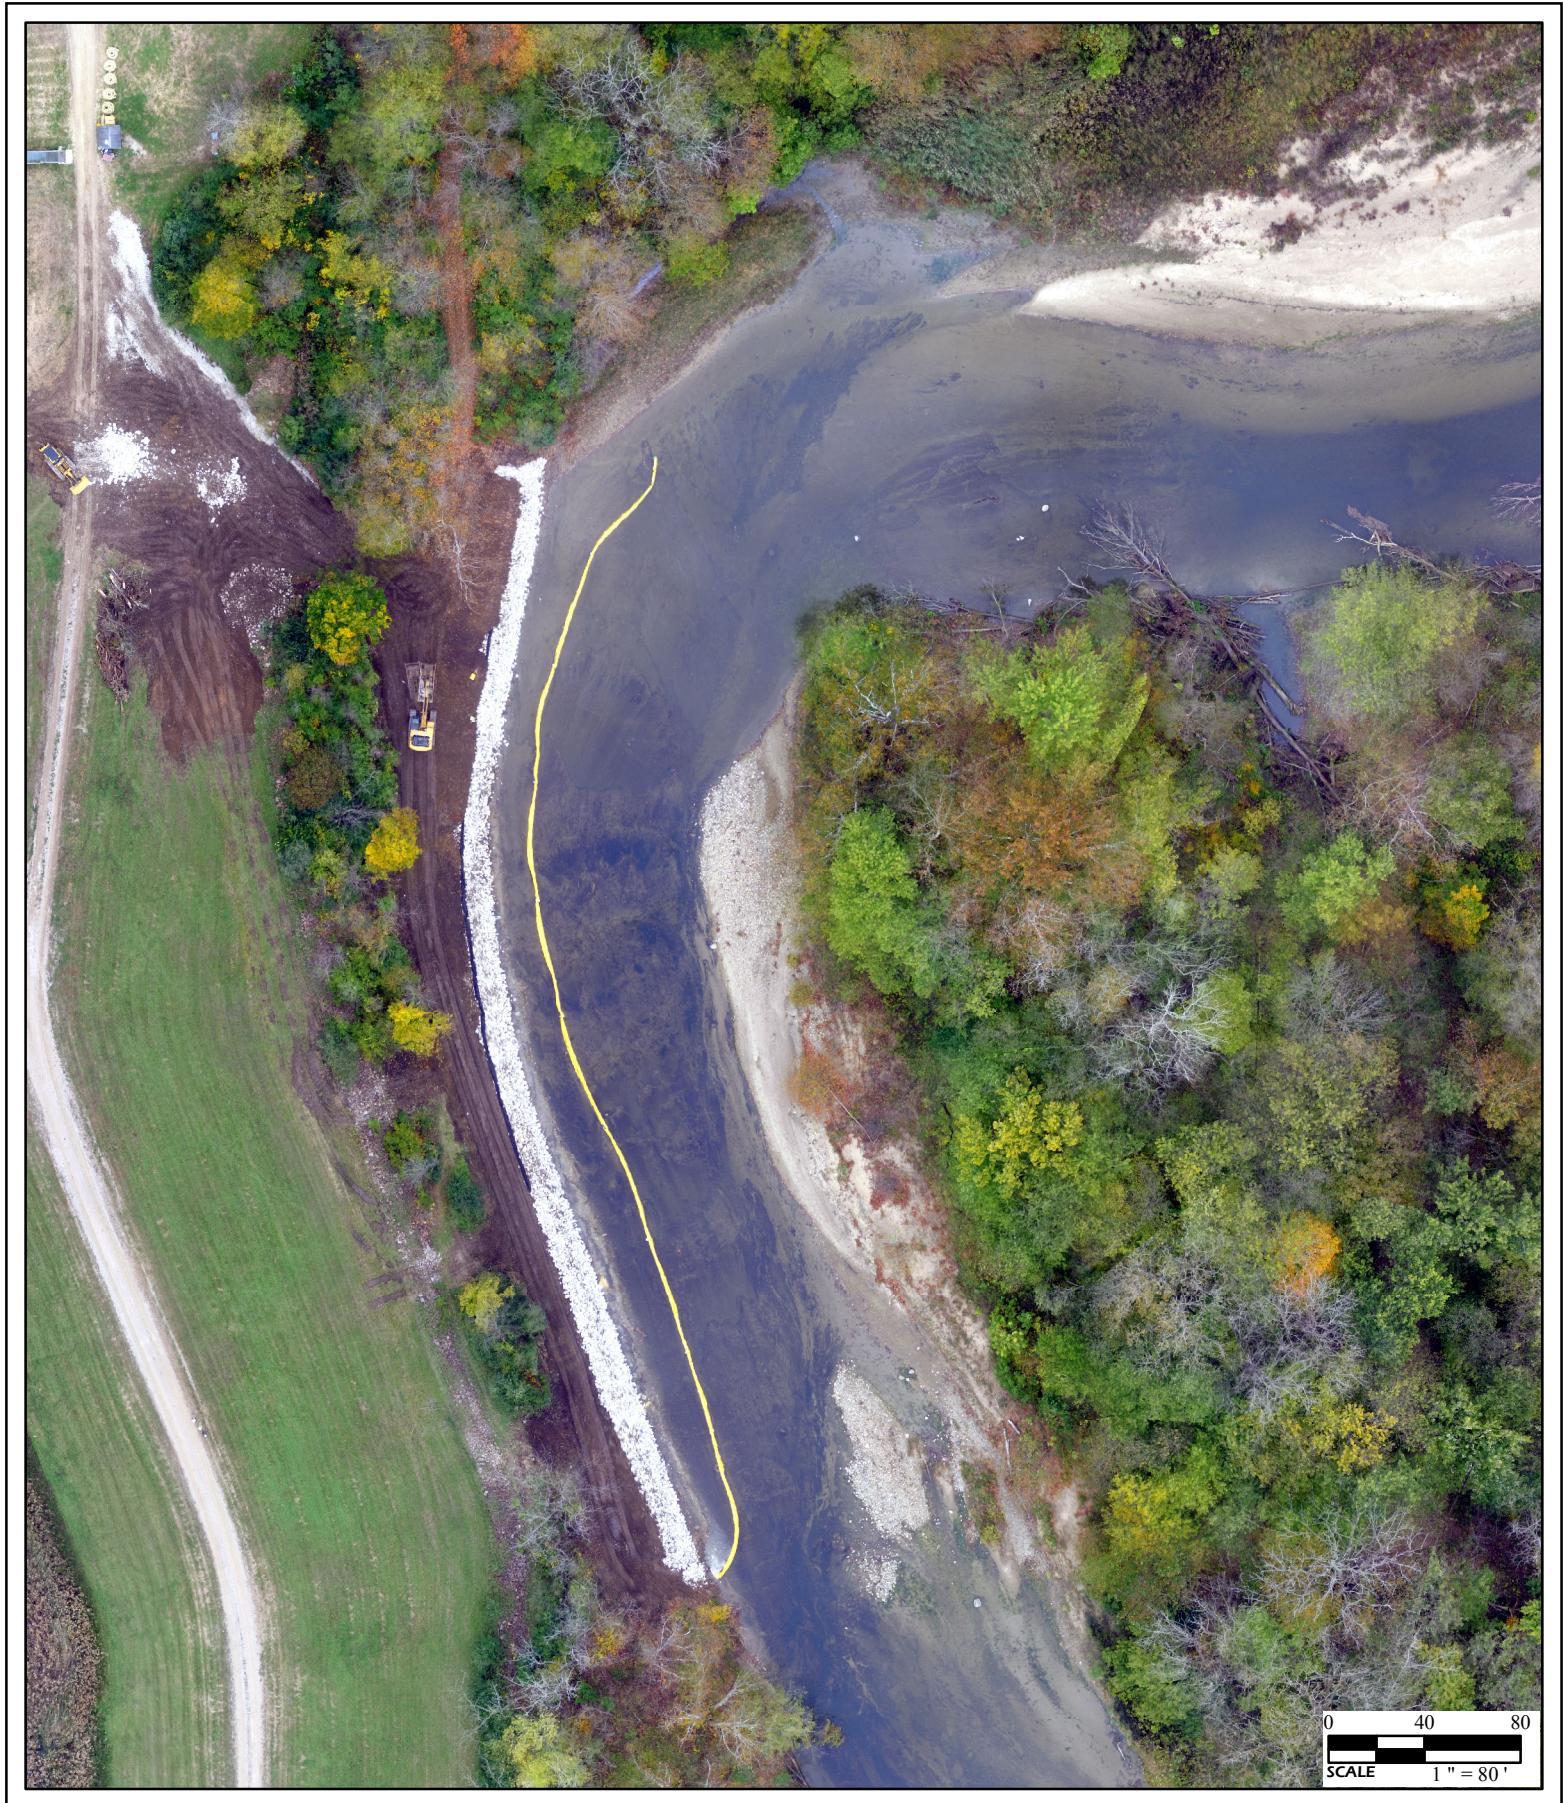
S	DYN	EGY MID VE OAK AERIA	ROJECT NAME WEST GENERAT RMILION SITE WOOD, ILLINOI L PHOTOGRA	ION, LLC – S PH	GENERAL NOTES/LEGEND	W E
=	DRAWN BY	RCV	DATE	JOB NUMBER	1	FIGURE
	CHECKED BY	MKW	02/2017	2009-3006.35	AERIAL PHOTOGRAPH OBTAINED FROM SCI UAV OPERATIONS, 10/27/2016.	2B

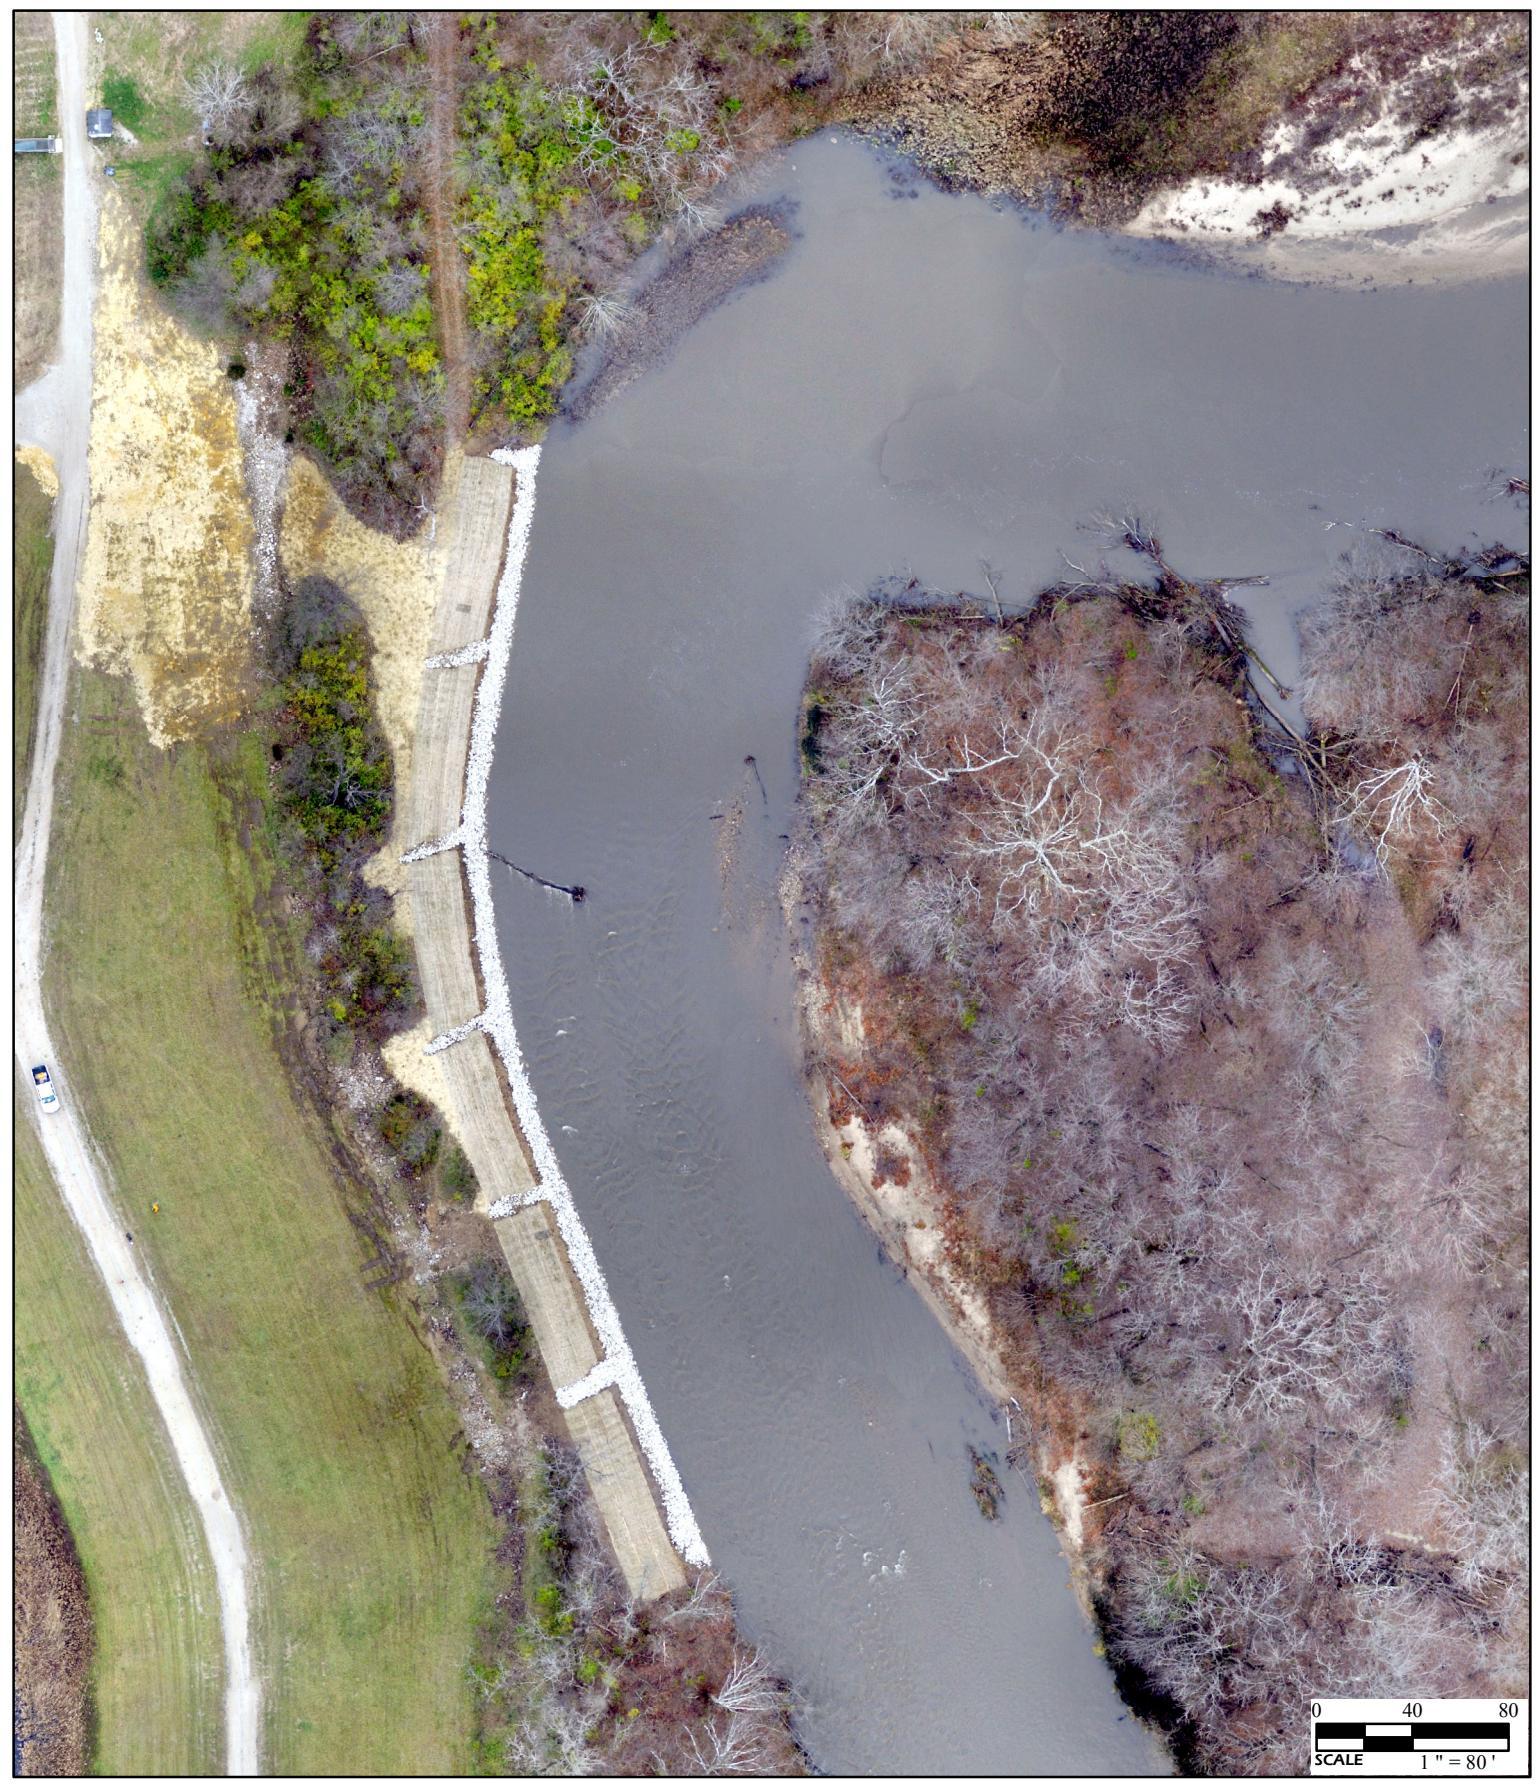
A follow-up site visit was conducted on December 1, 2016. The project appeared to be functioning as designed and the winter wheat cover crop was beginning to emerge. The project area appeared to be stable with no major items of concern at this time. However, some of the planted stakes that were planted closest to the MFV River have experienced some damage due to beavers. The beavers have trimmed some stakes down to only about three to four inches above-ground. Trapping of the beaver has begun to help minimize loss. However, as long as some of the stake is still present above-ground, it is likely the stakes will sprout in the spring. DMG personnel will continue to monitor the situation.

S	DYN	EGY MID VE OAK AERIA	PROJECT NAME WEST GENERAT RMILION SITE WOOD, ILLINOI L PHOTOGRA	ION, LLC – S PH	_GENERAL NOTES/LEGEND	W S S
	DRAWN BY	RCV	DATE	JOB NUMBER	1	FIGURE
	CHECKED BY	MKW	02/2017	2009-3006.35	AERIAL PHOTOGRAPH OBTAINED FROM SCI UAV OPERATIONS, 12/01/2016.	2C
