ILLINOIS ENVIRONMENTAL PROTECTION AGENCY

Memorandum

Investigation of Sediment in an Unnamed Tributary to Middle Fork Vermilion River

April 26 through May 12, 2016

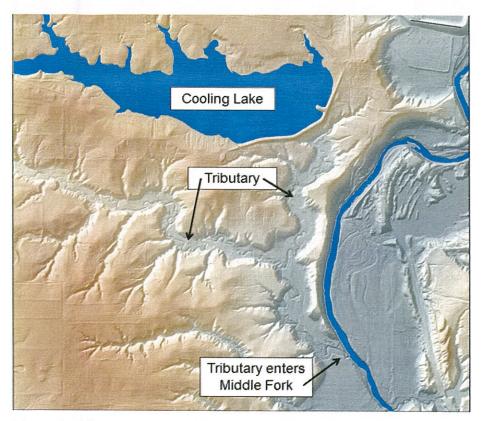
On April 28, Mr. Rehn sent another email with a map downloaded from the Illinois State Geological Survey. That map is Figure 2. The message said,

Figure 2 Lidar map provided by A. Rehn, Prairie Rivers Network.

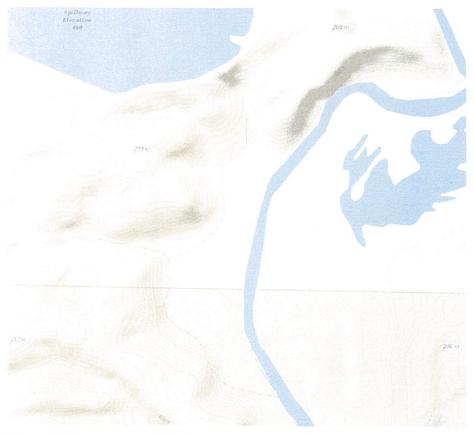
I went to the site where Mr. Rehn obtained the map. When I removed the hillshade layer, Figure 3 was the result. There are two tributaries shown, but the location of the reservoir spillway is not clear.

Figure 3 Closer view of Lidar map with hillshade removed.

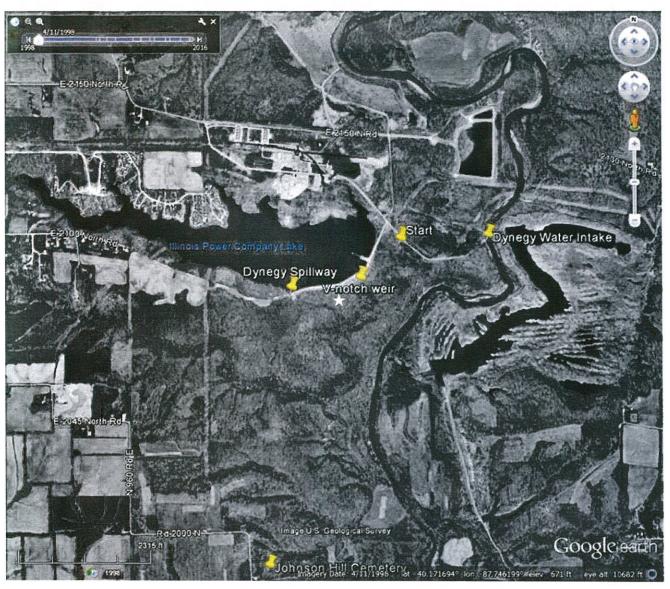
We drove to the location labeled Start in Figure 4. From there we began walking southwest, hoping to find the confluence of the Dynegy flow with the unnamed tributary to the Middle Fork. We descended into steep valleys with streams at the bottom at least twice. Photographs 4-7 show sections of the first stream we crossed.

After about 75 minutes we reached a location close to where I placed a white star on the map in Figure 4. (I had a GPS with me, but the readings were not consistent because of the tree canopy and the batteries were running low.) The channel from the reservoir ranged 6-12 feet wide. The flow was rapid with several sections of whitewater where it flowed over rocks. We were not able to cross the stream and it did not appear that we could reach the confluence without descending and climbing at least one more hill. We decided to follow the channel northwest to the spillway. All along the way, the water was turbid and a light brown color (photographs 8-12. When I located the spillway, I took photographs 13-14.

Figure 4 The base map is a Google Maps aerial view from 1998. All marker placements are approximate. The path of the spillway stream is visible, but faint.
